# Mortierongeval Mali 2016

Heropening onderzoek 2022

*Den Haag, augustus 2022*

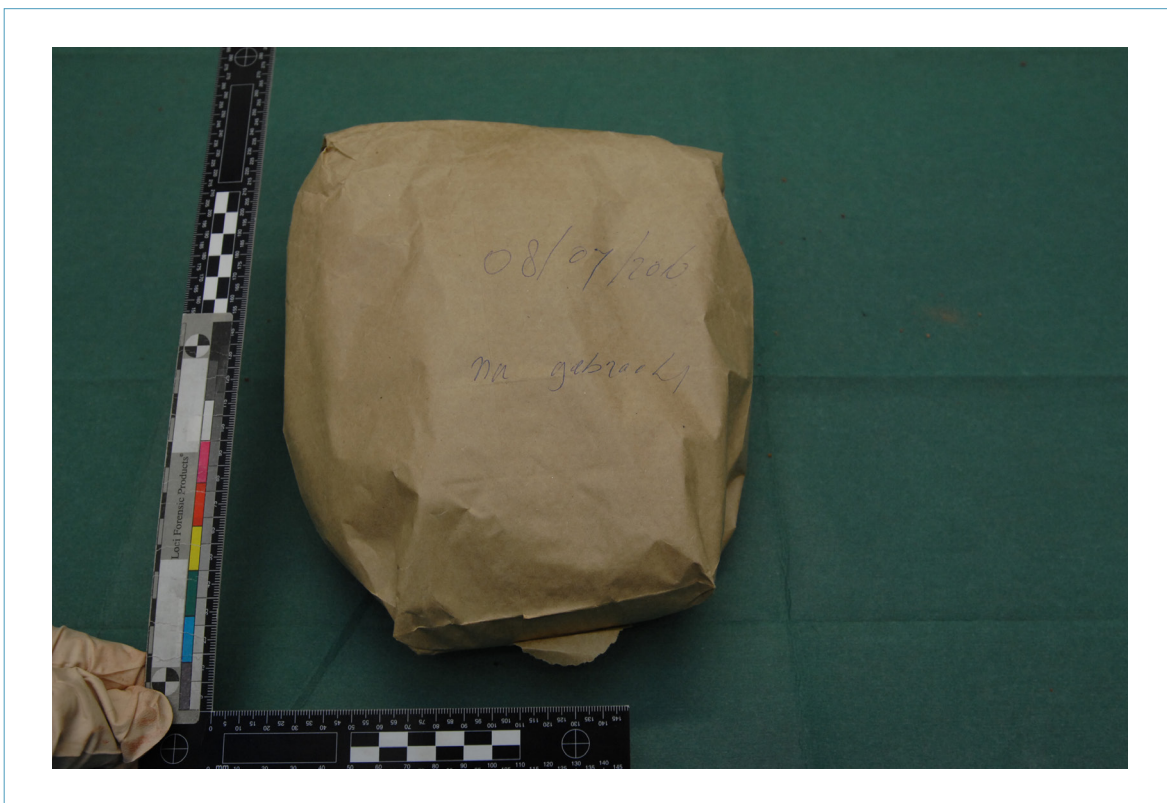
Figuur 1: De op 8 juli 2016 in Gao nageleverde bruin papieren zak<sup>21</sup>

Uit deze gereconstrueerde gang van zaken kan worden opgemaakt dat de granaatscherven en restanten in de bruine zak, die op 8 juli 2016 is afgeleverd bij de KMar in Gao, niet anders geduid kunnen worden dan als de granaatscherven en restanten die op 6 juli 2016 zijn verzameld tijdens de zoekactie direct na het ongeval. Ook kan worden uitgesloten dat tijdens de zoekactie direct na het ongeval de granaatscherven van de vóór het ongeval vernietigde blindganger zijn opgeraapt. De blindganger was terecht gekomen op ongeveer 500 meter afstand van de ongevalslocatie zonder te detoneren. Het zoekgebied van de ongevalsgranaat op de ongevalslocatie besloeg 100x100 meter.

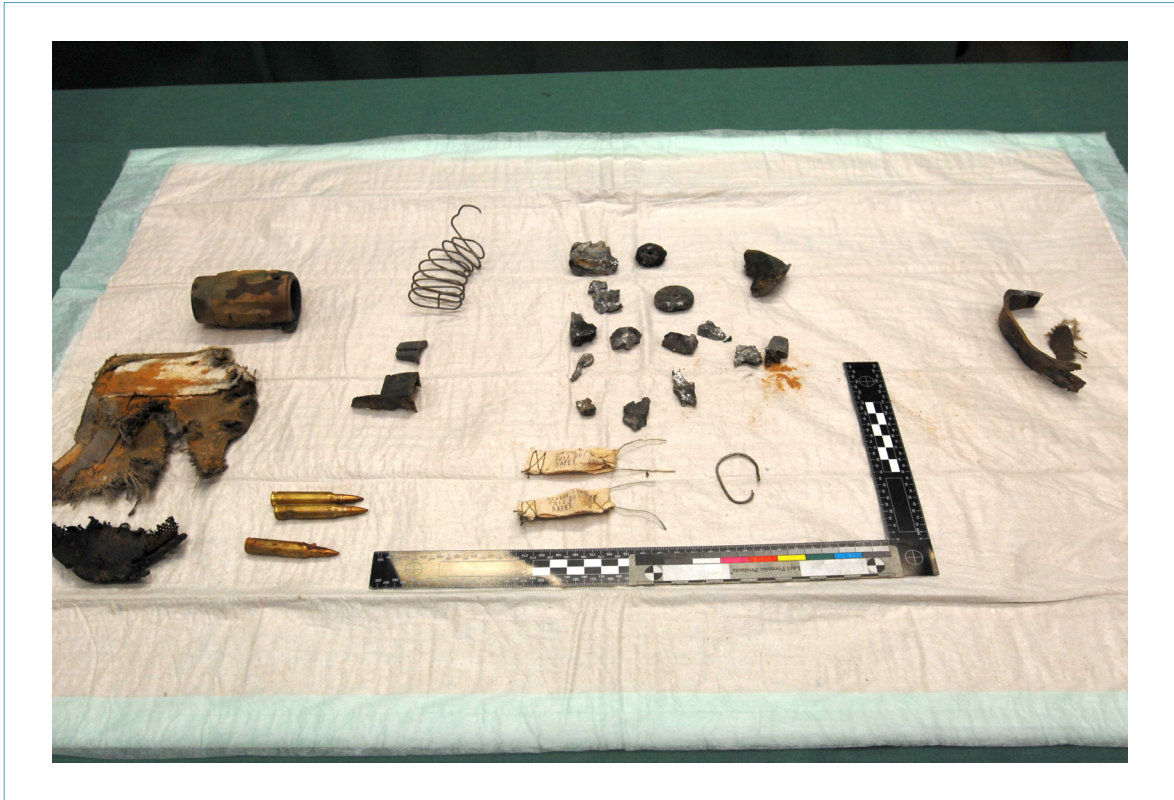
Figuur 2: de inhoud, verzameld bij de zoekslag vóór het vernietigen van de vijf granaten<sup>22</sup>

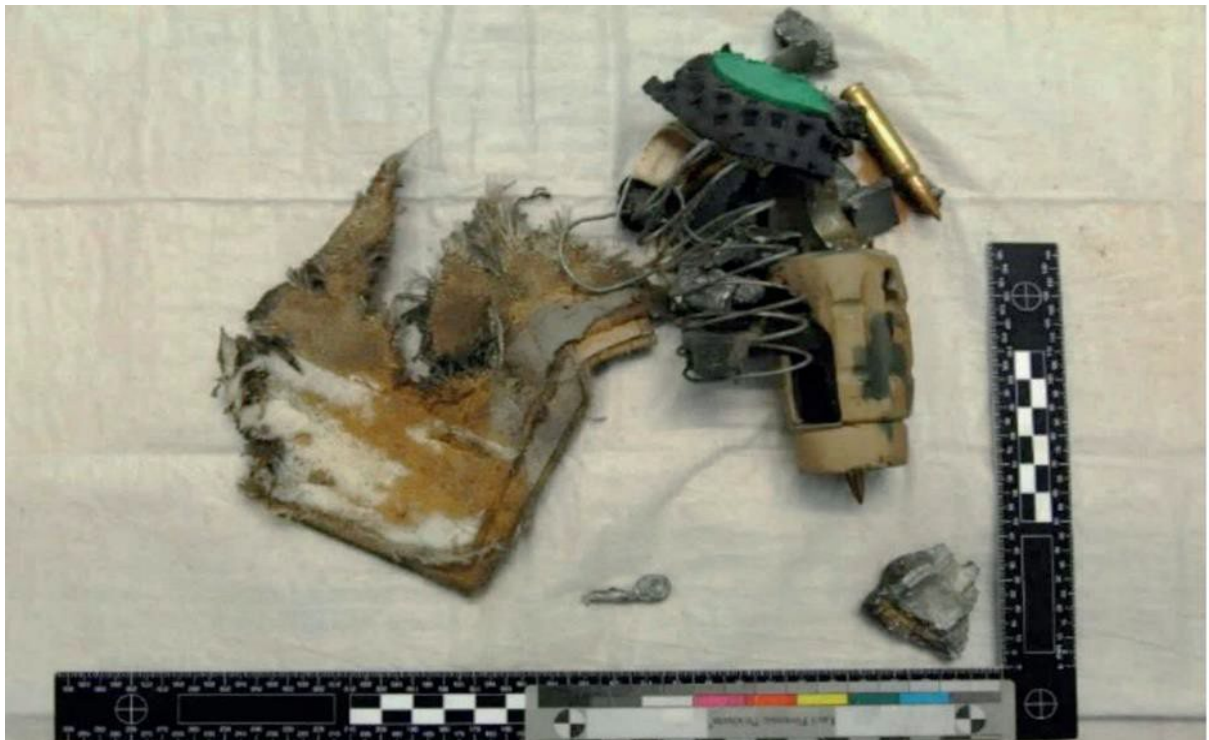
Figure 6: Content of the paper bag: visible are fragments of a shock pylon, a part of a shoe, rounds, a magazine spring, (probably) a cover of the mortar, straps of the transport safety of the grenade and the rubber cover of the sights of a Colt rifle. (Picture: TNO)

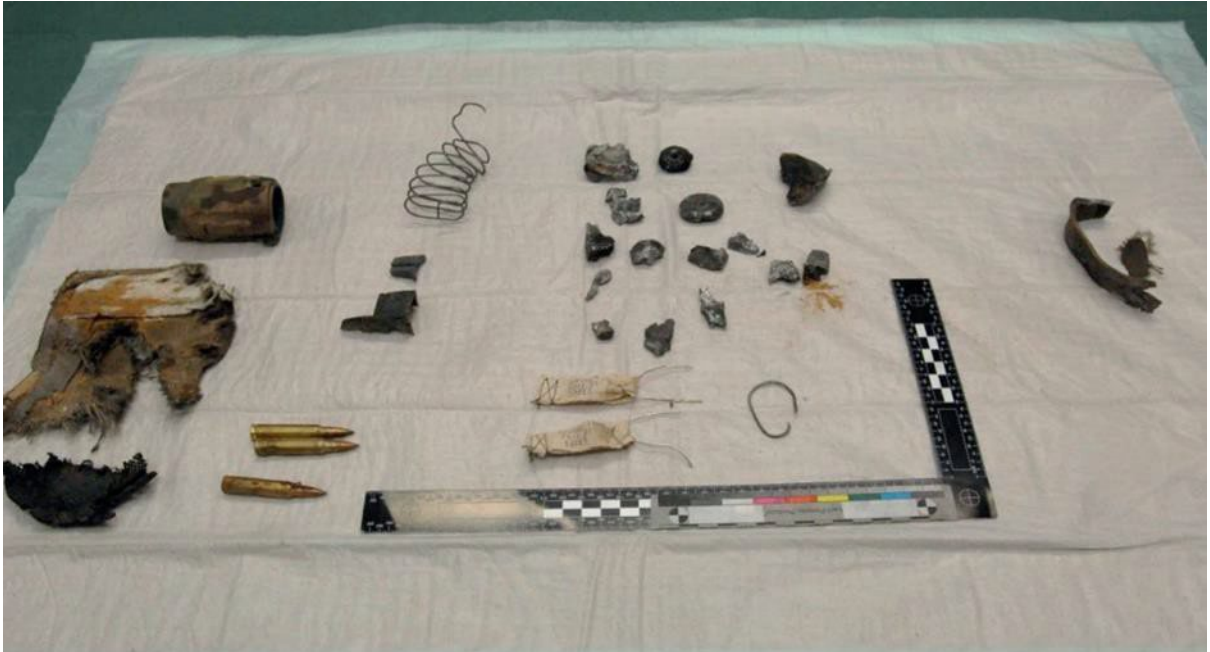
Figure 7: Content of the paper bag: visible are the same parts as in Figure 6, parts of a magazine and (probably) a part of the carrier/firing belt of the mortar. (Picture: TNO)

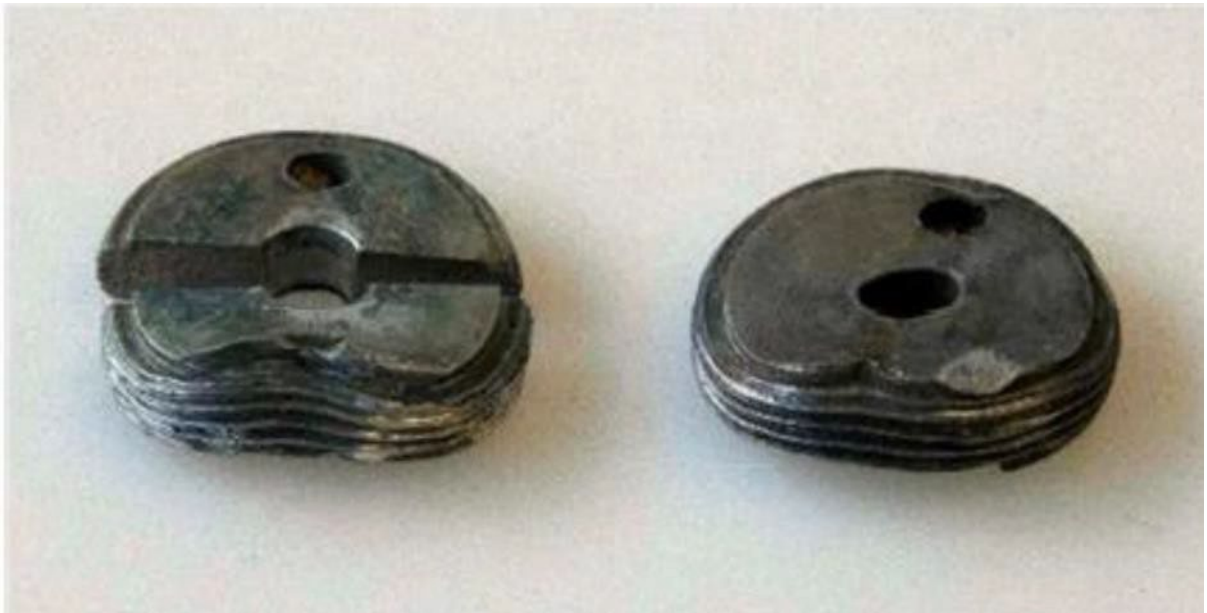
Figure 8: Left explosion train interrupter plate; DSB-report; right explosion train interrupter plate; controlled destruction. (Picture KC W&M)

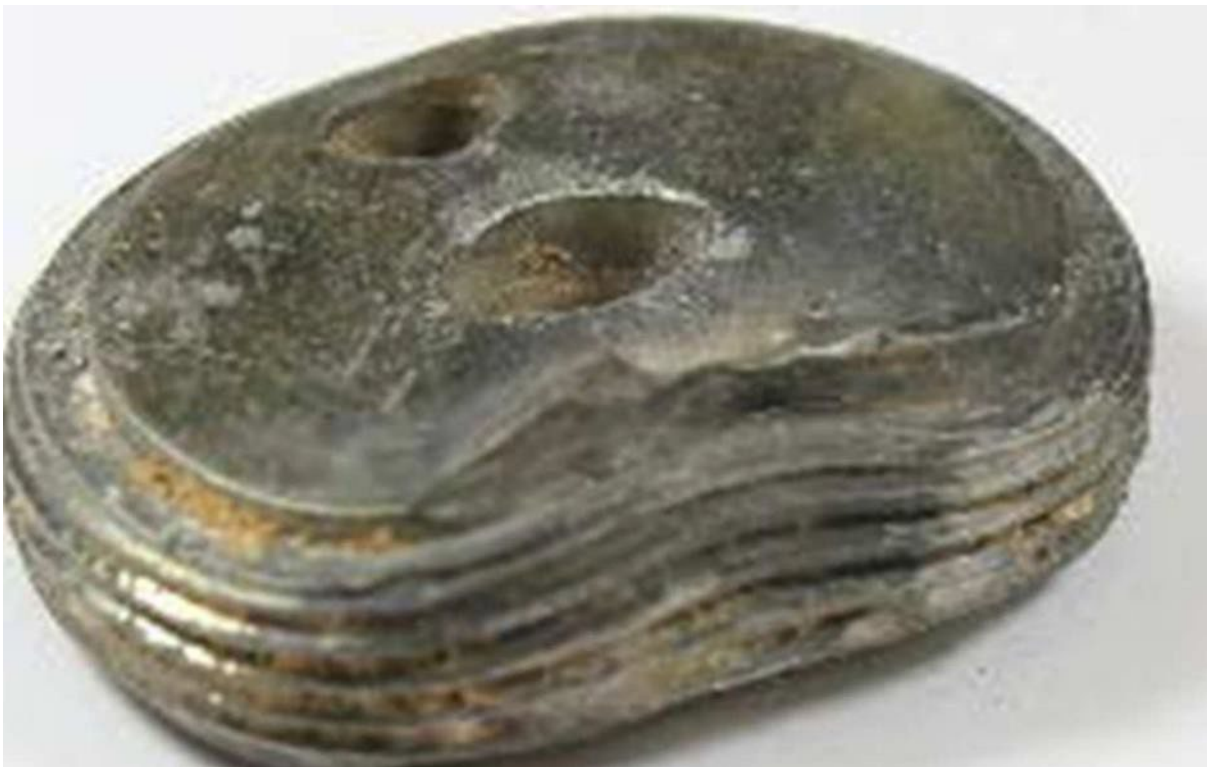
Figure 10: Enlargement of the cover plate shows possible presence of sand in the thread. (Picture: TNO)

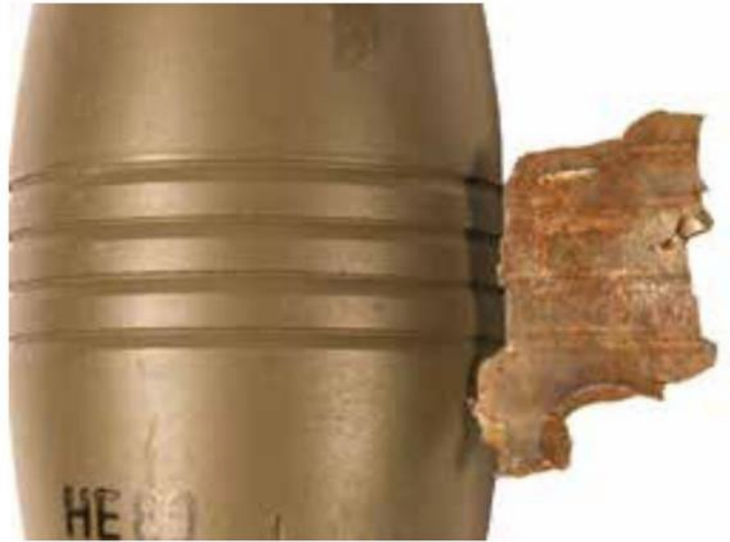
Figure 11: Imprint on the fragment of the launch tube, originating from the grooves on the shell casing when the main charge explodes. Figure illustrates the steel fragments produced during detonation of an HE 80 mortar round. (Picture: TNO)

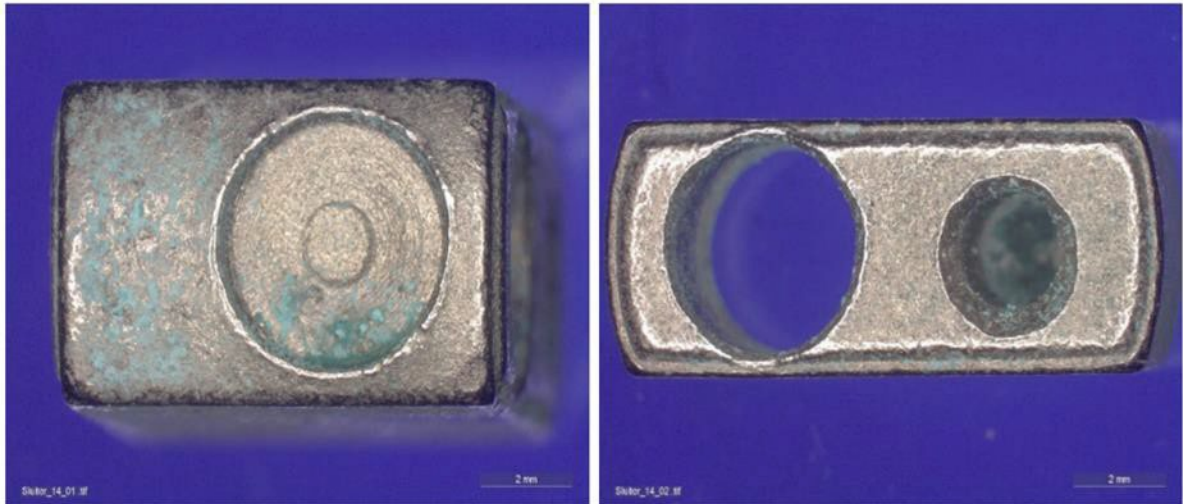
Figure 13: Optical micrographs of slider. Corrosion is visible on the side wall and in the recess for the slider spring (left) and on the top, on the edge of the hole for the detonator and on the edge of the recess for the firing pin (right). (Picture: TNO)

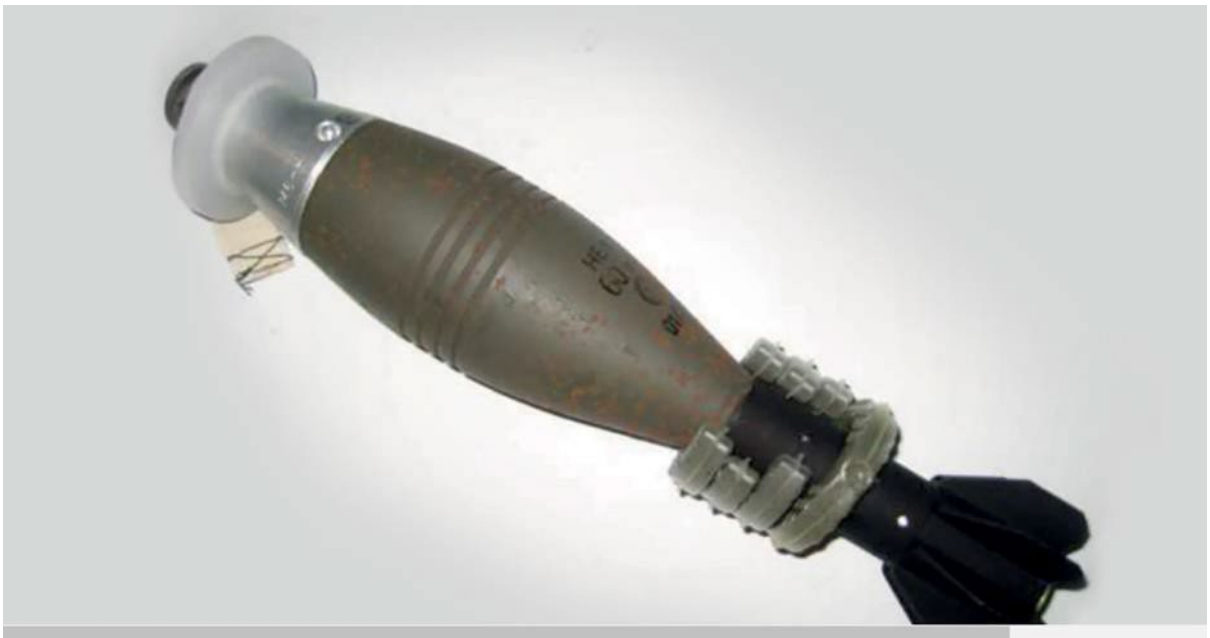
Figure 14: HE 80 Round. Corrosion identified during 2007 testing of new rounds. (Picture: Netherlands Ministry of Defence)

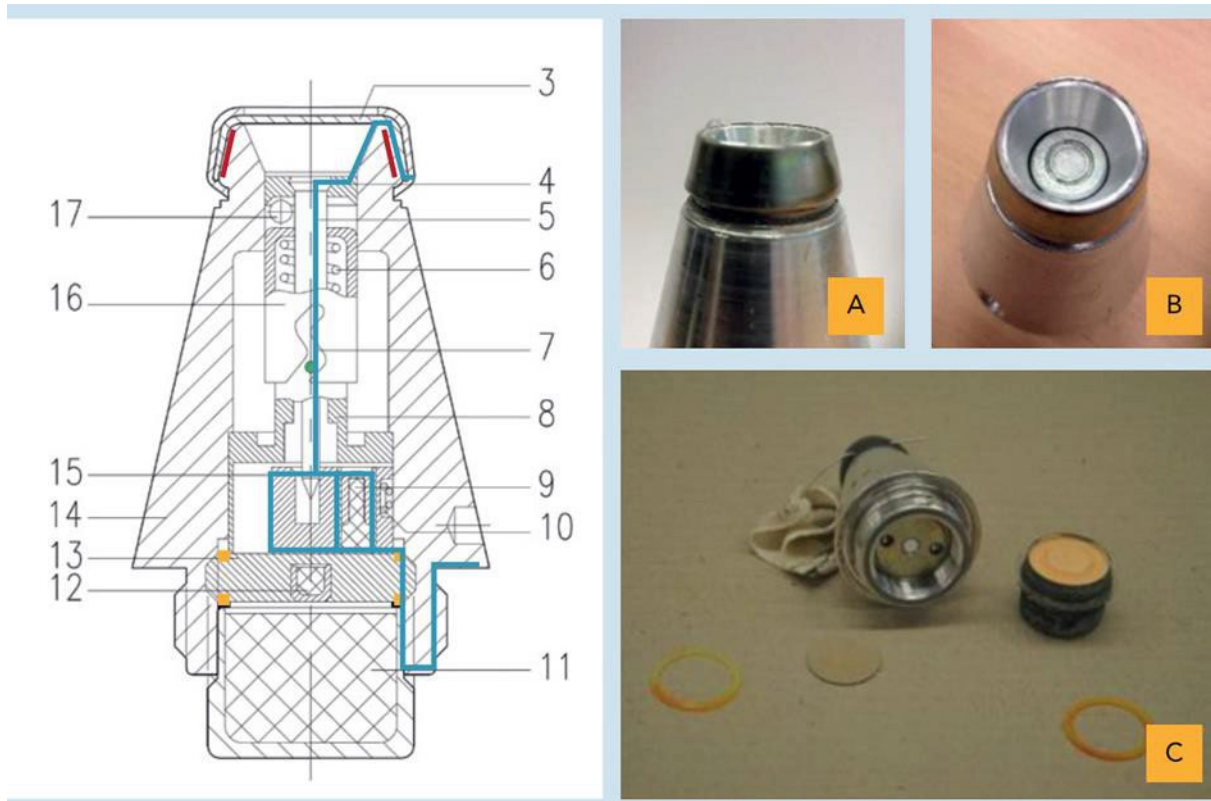
Figure 15: Cross section of the fuze with potential routes (blue) for moisture penetration via the adhesive layer (red) and sealing rings (yellow). Picture A: adhesive layer for the membrane, picture B: opening between the firing pin and the housing. Conclusion is that moisture ingress more likely via top of fuze. (Source: TNO)

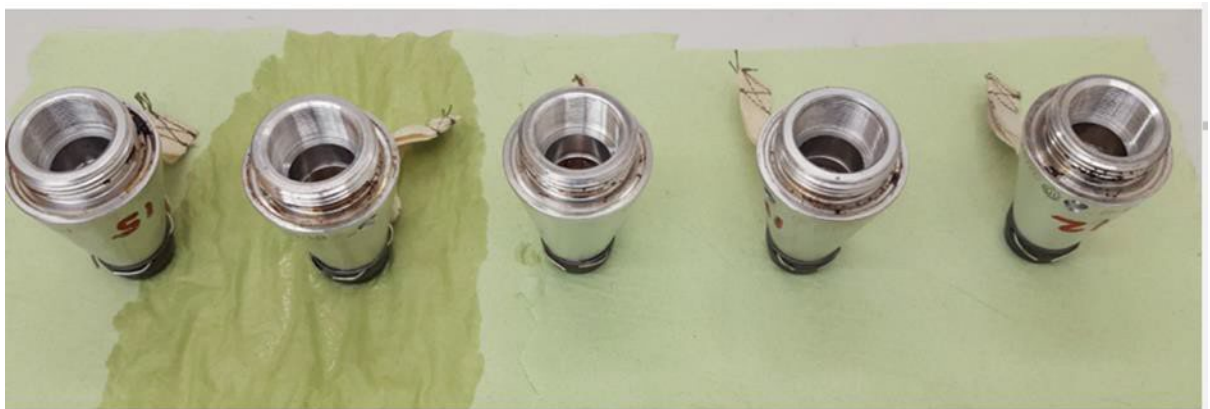
Figure 16: Filling the top of the M6-N fuze with water to show leakage. The adhesive layer of one of the five fuzes tested is leaking after a drop test from about one metre height with random impact orientation. (Picture: TNO)

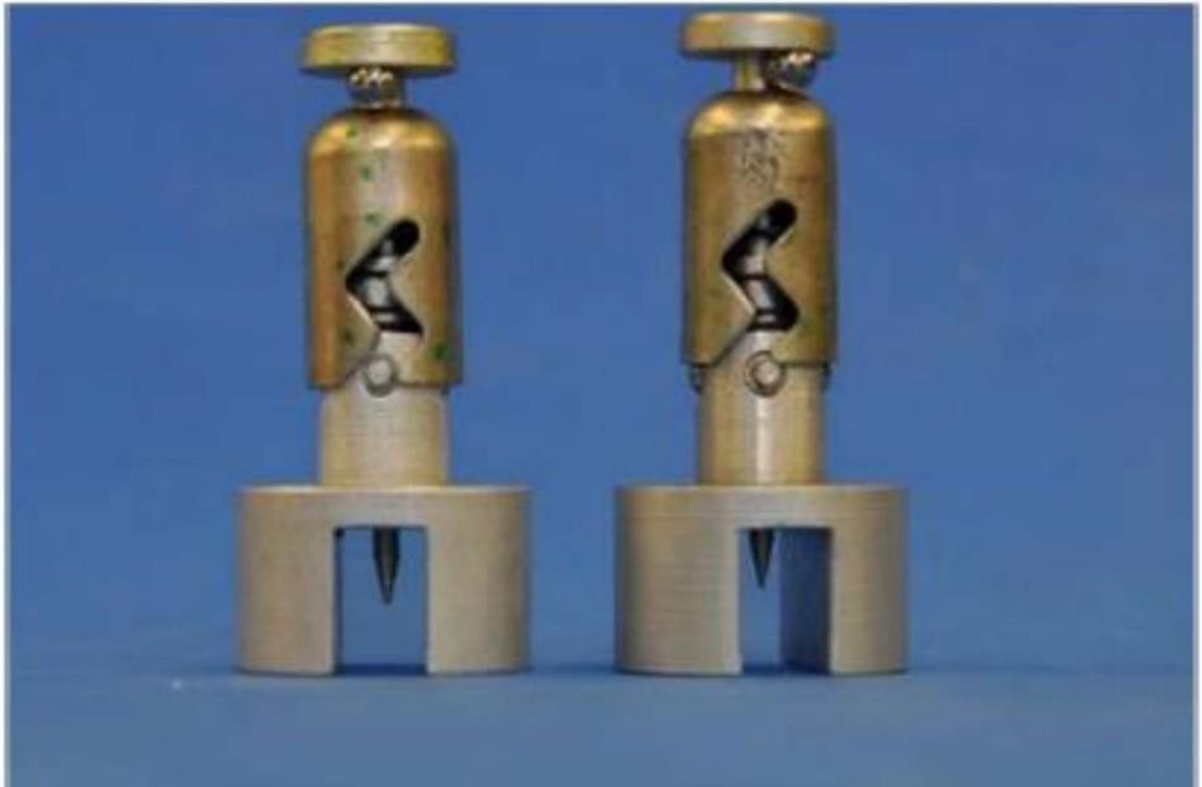
Figure 25: Combination firing pin and non-return valve; left correct; right incorrect (Photo: KC W&M)

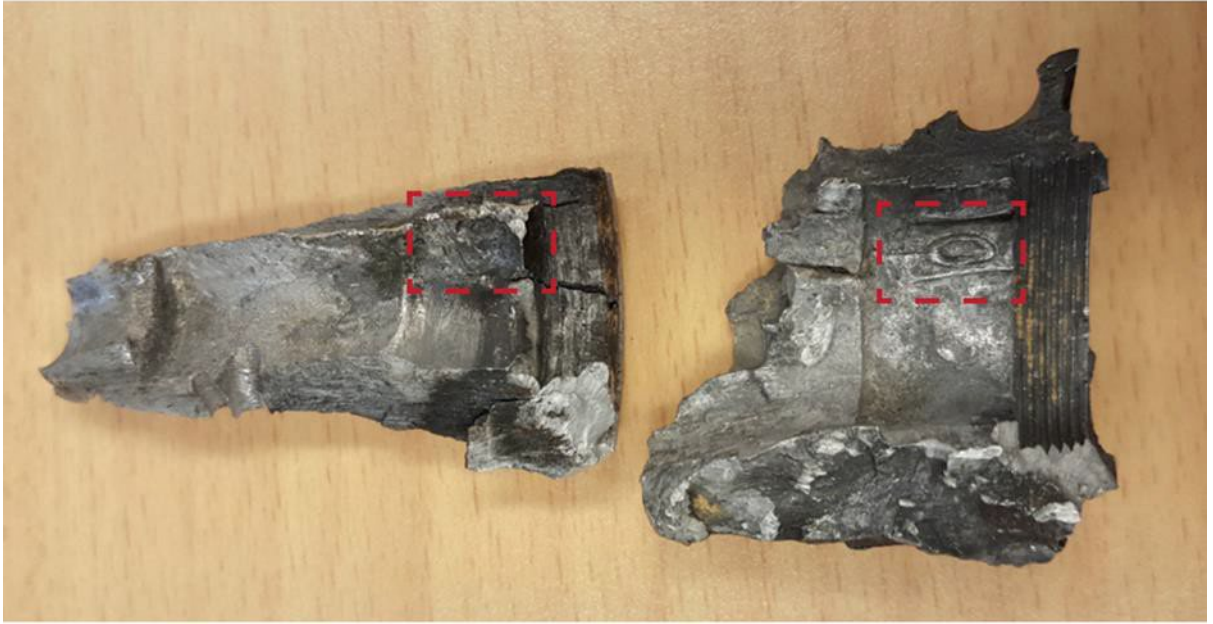
Figure 27: Imprint of the slider and slider spring on the inner wall of the fuze body from the test in armed position (left) and on the inner wall of the fuze body from the accident mortar round (right). (Picture: TNO)

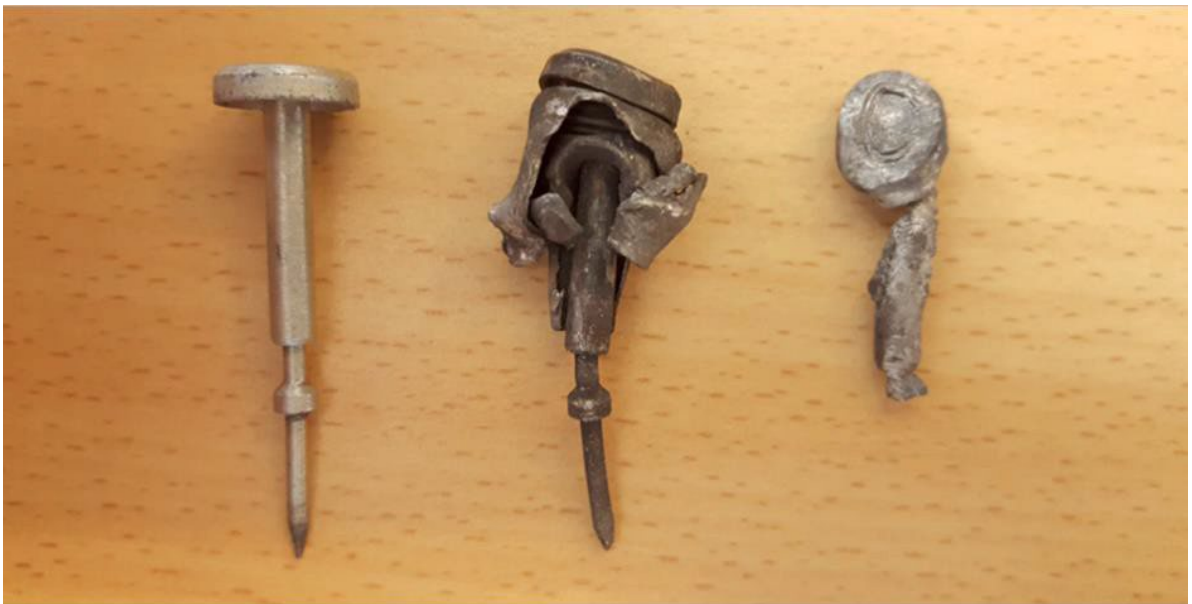
Figure 28: Unused firing pin (left), firing pin from the test in armed position (centre) and from the accident mortar round (right). (Picture TNO)

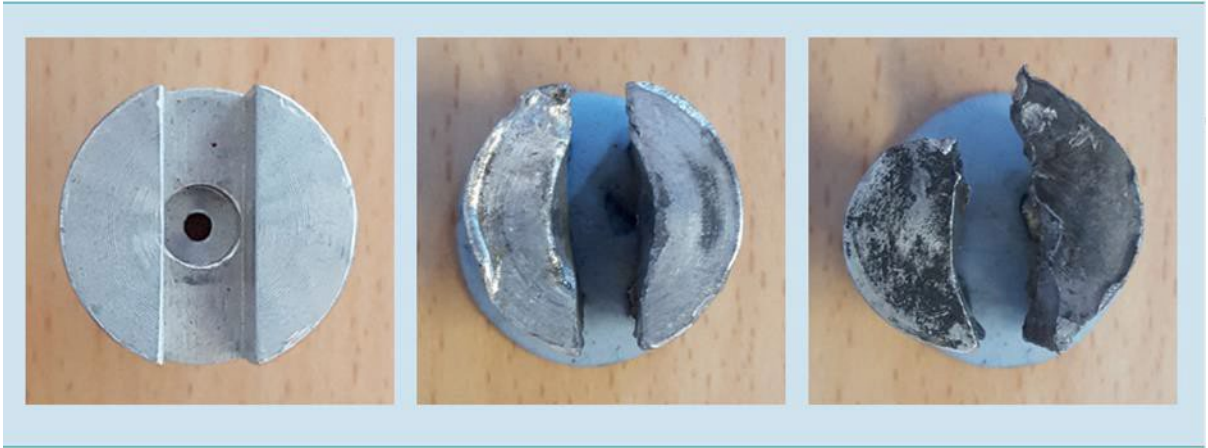
Figure 29: Bottom view of an unused firing pin housing (left), from the test in armed position (centre) and from the accident mortar round (right). The greater asymmetry in the accident round can be interpreted as reflecting the detonator being off-centre in the 'safe' position. (Picture: TNO)

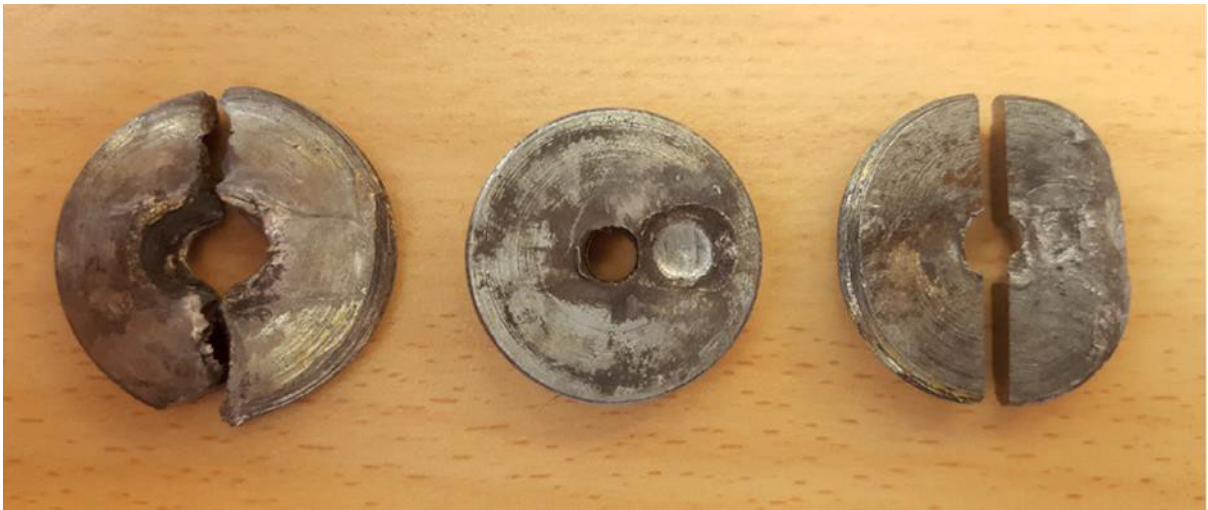
Figure 30: Top surfaces of the explosive train interrupter plate from the test in armed position (left), from the test in safe position (centre) and from the accident (right). The plate from the test in armed position is broken as a result of the detonation, the plate from the accident was recovered in one piece, but cut in half for further examination. The off-centre dent in the accident plate is thought to demonstrate the detonator fired in the 'safe' position. (Picture: TNO)

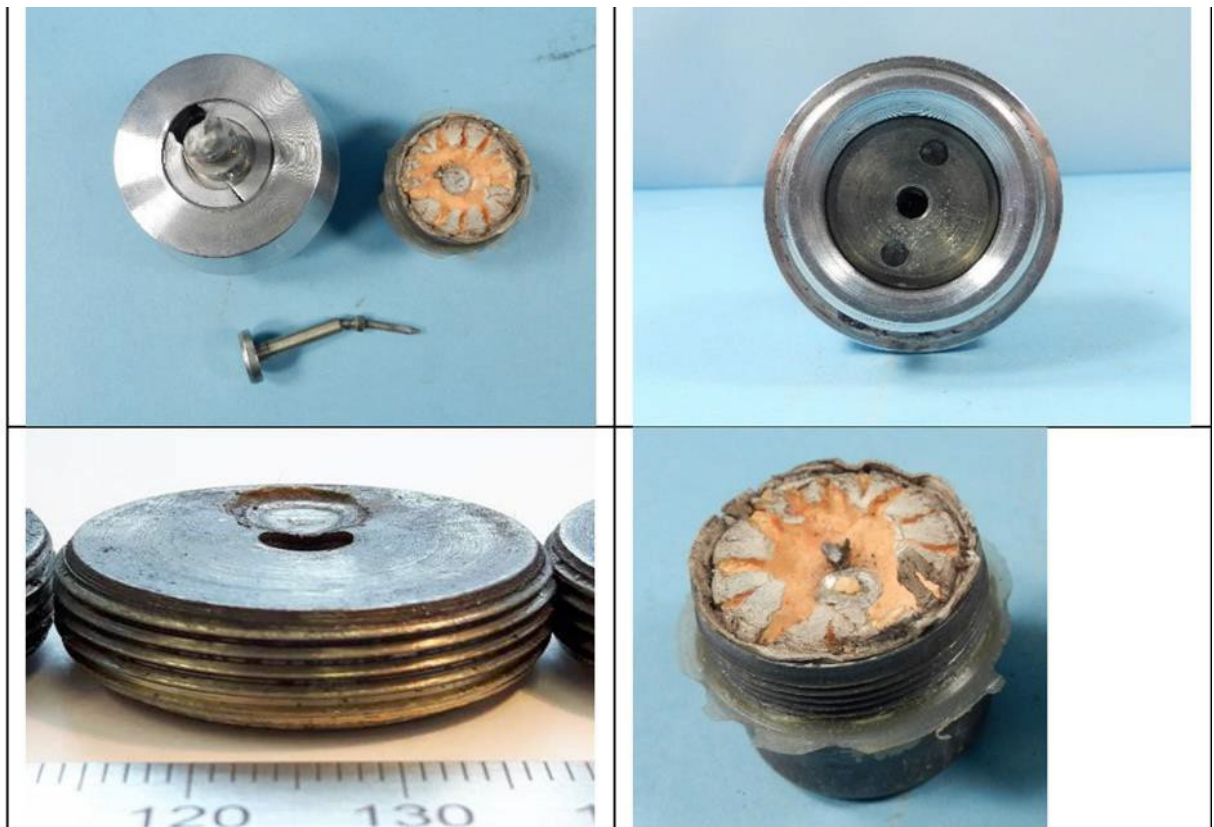
Figure 32: Pictures from TNO Explosives train interruption test, from top left, clockwise: impact fuze after the experiment; bottom surface of the barrier with debris of the lead charge cup; indentation of base of the lead charge cup in the booster charge; impacted interrupter plate with an indentation at the location of the duplex detonator. (Picture: TNO)

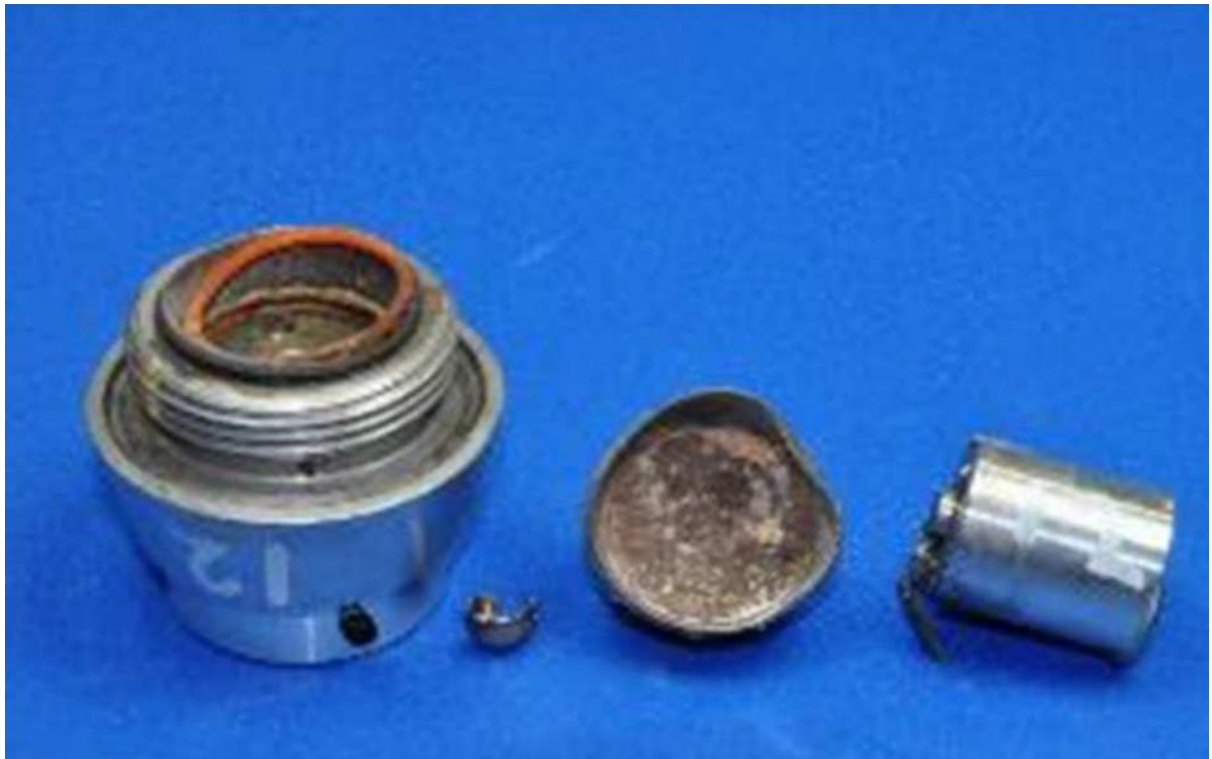
Figure 34: Explosive train interruption test carried out at 63°C by KC W&M. The booster charge has not detonated but it has fully combusted. In a higher confinement condition, as in an HE 80 round, transition to detonation may have occurred. (Picture: KC W&M)
