DUTCH  
SAFETY BOARD

# Crashed after banner pick-up, Piper PA-25-235 Pawnee

*The Hague, May 2021*

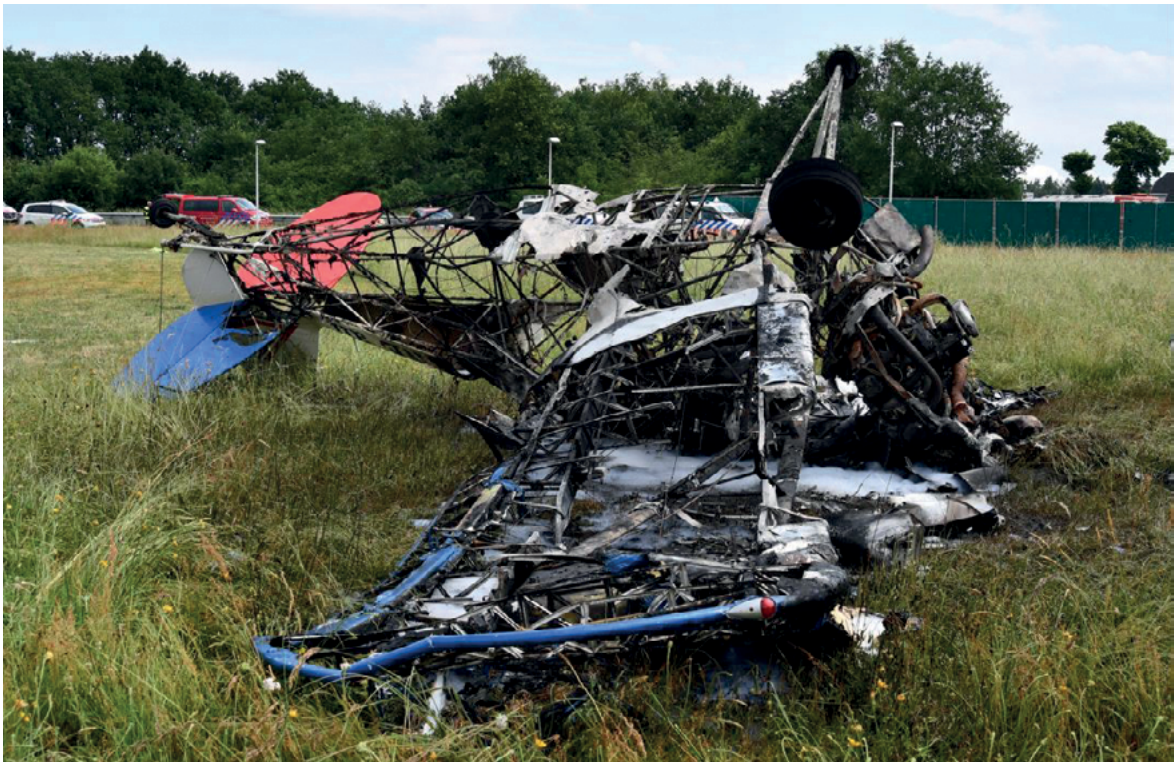
*Figure 4: Wreckage of SE-KHF. (Source: Dutch Aviation Police)*

The aeroplane was destroyed by the impact of the crash and subsequent fire. Although most of the aeroplane was severely damaged, a technical investigation was performed on the engine, cockpit controls, banner tow release system and the propeller. The following findings were made:

- a. The technical state of the engine did not reveal any malfunctions.
- b. The cockpit engine controls were found to be in the following positions: throttle – *full power*, mixture – *rich* and carburettor heating – *cold*.
- c. The aeroplane was equipped with a towing and tow-release installation. The banner release installation was tested and functioned normally.
- d. The wooden propeller blades of the 4-blade propeller were completely fragmented on impact with the ground, only the propeller hub/core was still attached. The fragmentation of the propeller blades showed that the engine was running at high rpm.

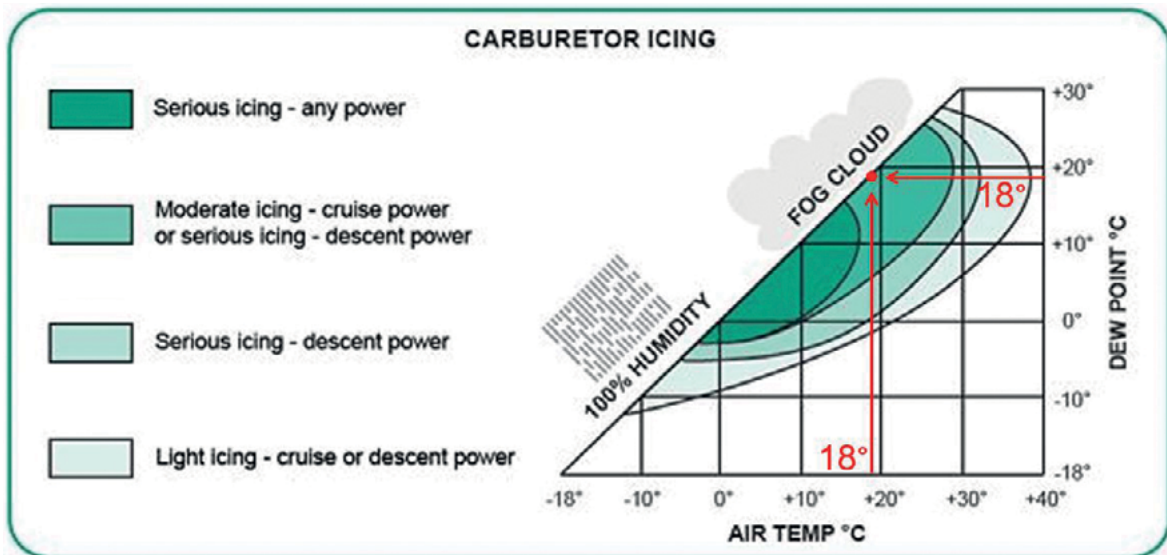
Figure 7: Carburettor icing prediction chart. (Source: Canadian Transportation Safety Board)

The actual carburettor icing conditions at the moment of take-off are notable and should be considered. The outside air temperature at the time of take-off was 18 °C and the dew point temperature was also 18 °C. With these temperatures the red dot in Figure 7 shows that the conditions were favourable for moderate to serious icing during cruise and descent with a low power setting. SE-KHF flew one circuit in the pattern of Breda Airport, before the pick-up of the banner. This is considered similar to a cruise/descent phase of flight. The carburettor heating controls in the cockpit were found in the 'Cold' position; which was the correct position during the pick-up and climb out with a high power setting. From downwind to just before the pick-up, the correct position is "hot", to prevent carburettor icing and guarantee maximum available engine power during the pick-up. It is unknown what the position was during the circuit.

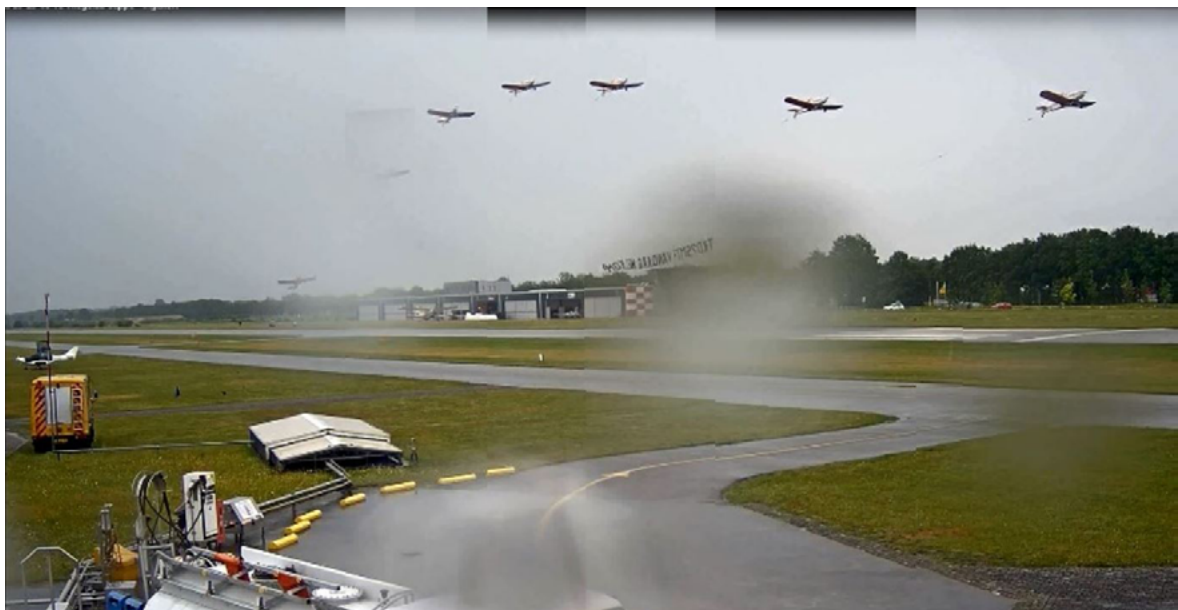
Figure 8: Video compilation showing the moment of the banner pick-up and the descending flight path.  
(Source: Breda International Airport, modified by the Dutch Safety Board)

The flight path reconstruction in Figure 8 shows that after the pick-up of the banner, the aeroplane quickly developed a nose high attitude and a descending flight path. These indications are characteristic for a low airspeed situation. Therefore, an estimation of the aeroplane's hypothesized low airspeed was made by using the video images.

The aeroplane flew 620 metres from the position where it picked up the banner until the position where it fell over its right wing in 30 seconds. From this distance and time, a ground speed of 47 mph IAS (41 KIAS) (21 m/sec) was calculated. Taking into account that a head wind component of approximately 6 mph (5 knots) was present (the windsock is hanging almost vertically down), the aeroplane flew with an estimated average airspeed of 53 mph IAS (46 KIAS).

minimum indicated airspeed for the similar type aeroplane is 67 mph<sup>20</sup> IAS (58 KIAS). By comparing these airspeeds with the above calculated average airspeed, it is inferred that the airspeed had decreased to below the minimum recommended flying airspeed for normal and for banner towing operations, and that as a result the aeroplane had stalled.

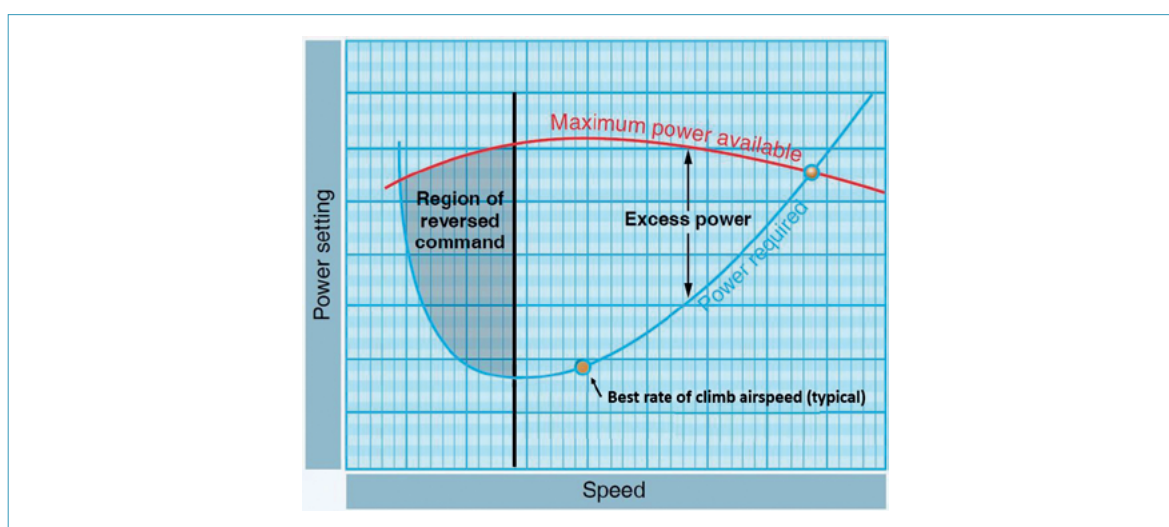
Figure 9: Typical region of reversed command. (Source: FAA, modified by the Dutch Safety Board)

At the calculated average airspeed, the aeroplane was flying in the 'region of reversed command'. Figure 9 illustrates a typical region of reversed command, indicating that when flying at airspeeds below the best rate of climb airspeed, more engine power (thrust) is required to maintain a lower airspeed. This is indicated by the power required curve (blue line) going left and upwards. It also shows that the power required curve on the left side of the graph has a steep rise, indicating that when the thrust deficient situation is not corrected promptly, the decrease in airspeed worsens at an increased rate.

At a certain point after the pick-up, the airspeed had decreased to where the aeroplane was flying in the region of reversed command. This means that flying a lower airspeed required more thrust to maintain that lower airspeed or to accelerate. Hence, the situation worsened as the speed of SE-KHF was decreasing gradually after picking up the banner. This situation could only be resolved by applying sufficient engine power (thrust) and/or by exchanging altitude (nose down) to increase the airspeed. The pilot could do neither of these, having an improper propeller fitted and being too low to the ground.

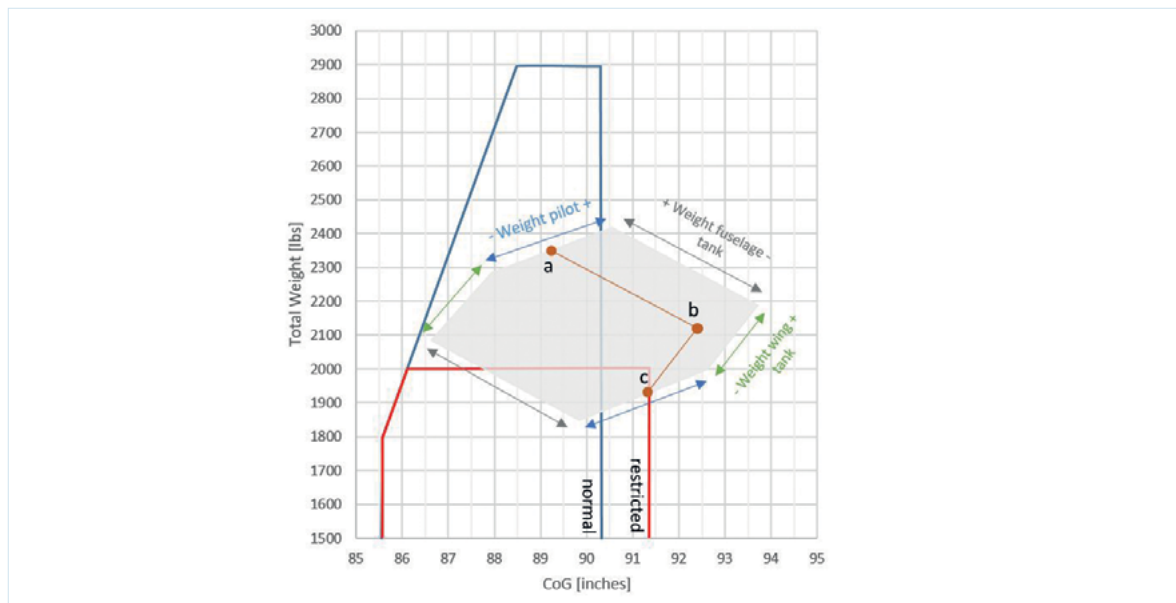
Figure 10: The centre of gravity limits for the normal and restricted categories (SE-KHF).

The graph in Figure 10 illustrates the aircraft flight manual weight and balance regions for the normal (blue) and restricted (red) categories.<sup>34</sup> The graph further shows the actual weight and balance region of SE-KHF (grey area). The line 'abc' within the grey area, shows the centre of gravity change as a result of decreasing weight due to fuel consumption.
