# Stability of beam trawlers

RC22C003-1999-rev04

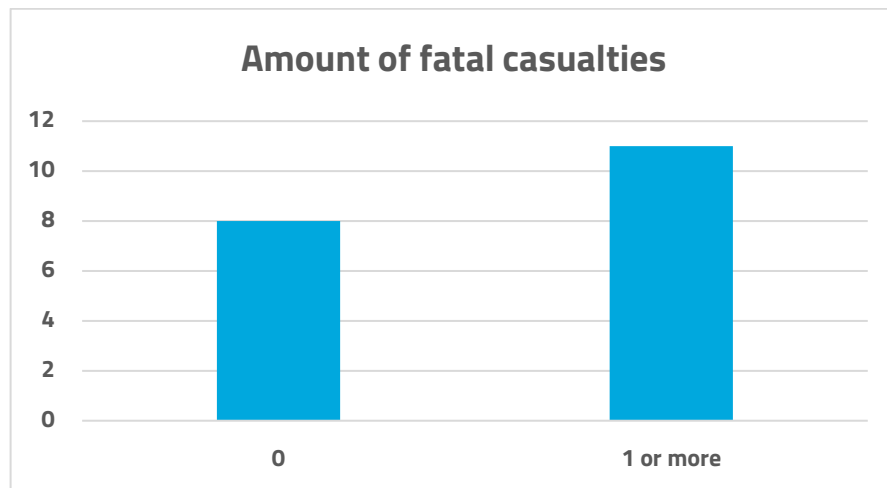
Number of fatal casualties: from the number of 19 investigated accident reports, covering a period of 1991 – 2020, the total number of fatal casualties is 34. Resulting in an average of 1.8 fatal casualties per accident. The diagram below shows that more than 50% of the accidents feature one or more fatal casualties.

Figure 1: Amount of fatal casualties involved in the analyzed accidents.

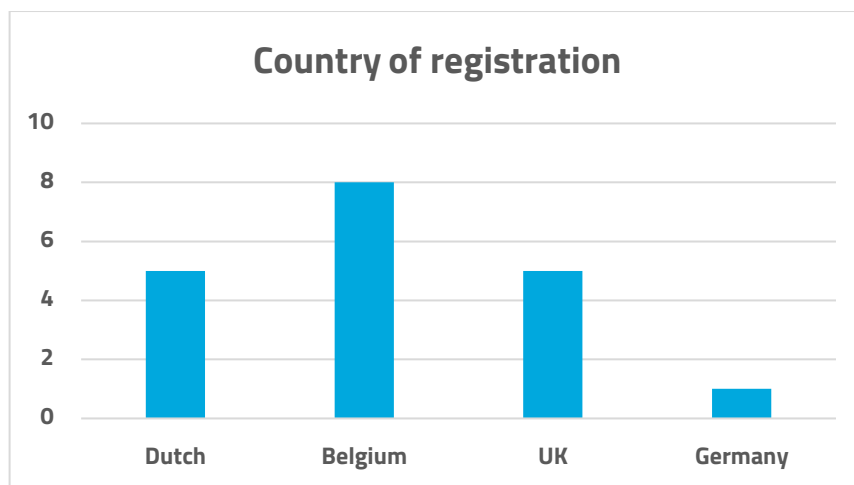
Several countries appear in the accident reports, of which: The Netherlands, UK, Belgium, Germany. See Figure 2.

Figure 2: Countries that appeared in the analysed accidents.

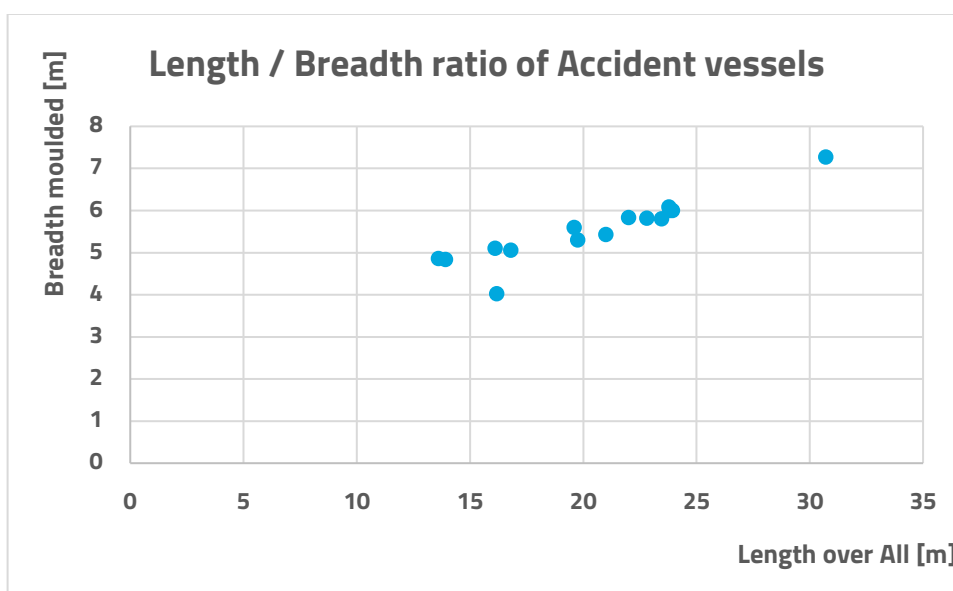
Except for one, all vessels involved in these accidents have a length of less than 24m. This is presented in Figure 3, indicating the length/breadth ratio of the vessels.

Figure 3: Length/Breadth ratio of accident vessels.

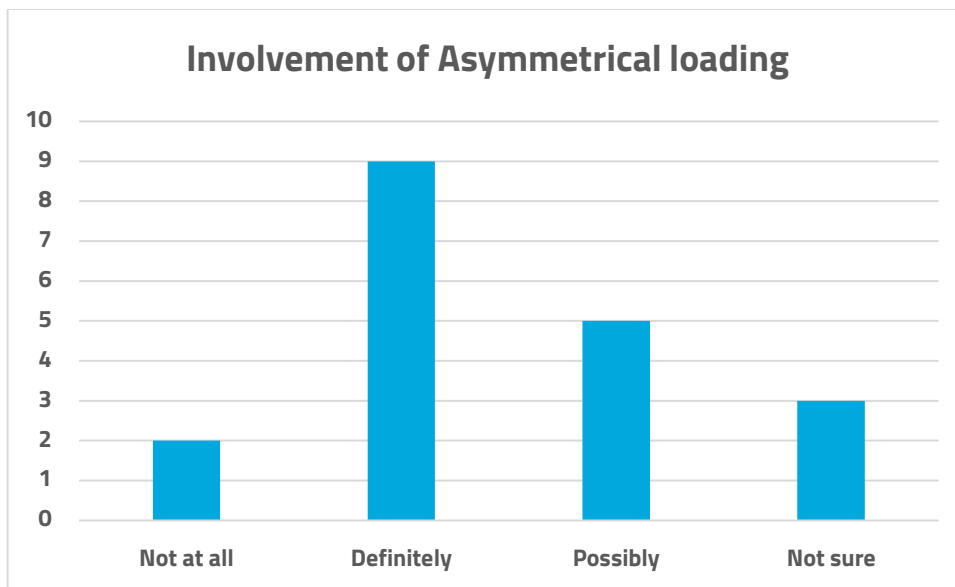
From the accident reports, it has been extracted if the capsizes was caused by asymmetrical loading; either if one of the nets got stuck, a difference in cargo weight in one net compared to the other, or asymmetrical loading on deck. It can be concluded that in 47% of the cases, asymmetrical loading definitely played a key role. And in at least 74% of the cases asymmetrical loading definitely or possibly played a key role. This is illustrated in Figure 4.

Figure 4: Involvement of asymmetrical loading in the analyzed accidents.

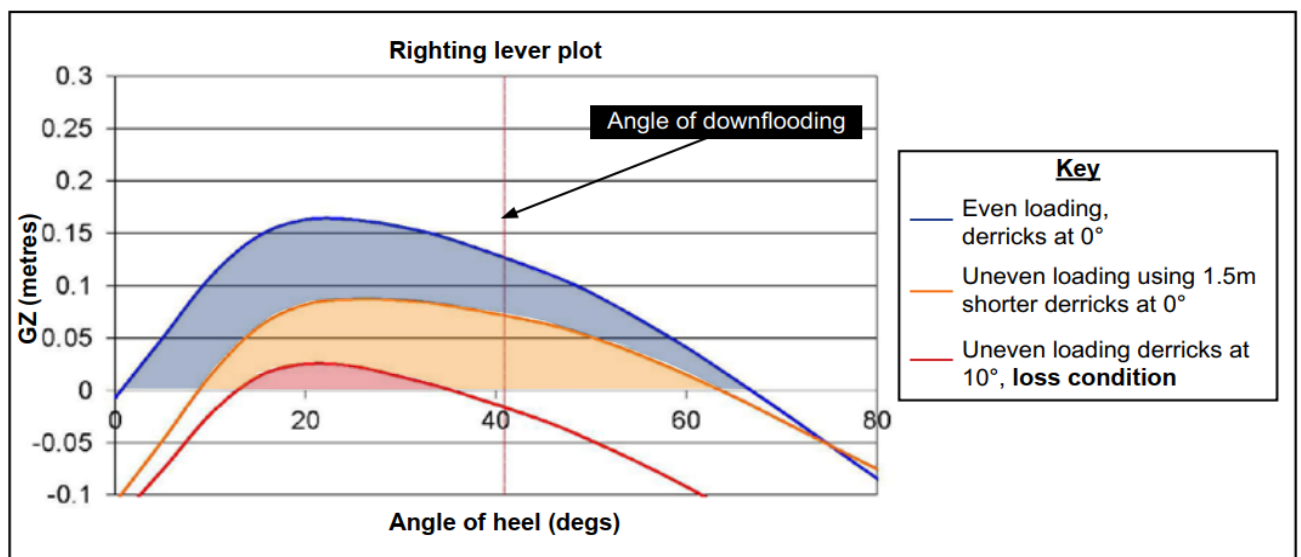
Figure 5 Righting lever plot showing the effect of several uneven loading conditions [ (MAIB, Capsize and foundering of beam trawler Sally Jane, 2014)]

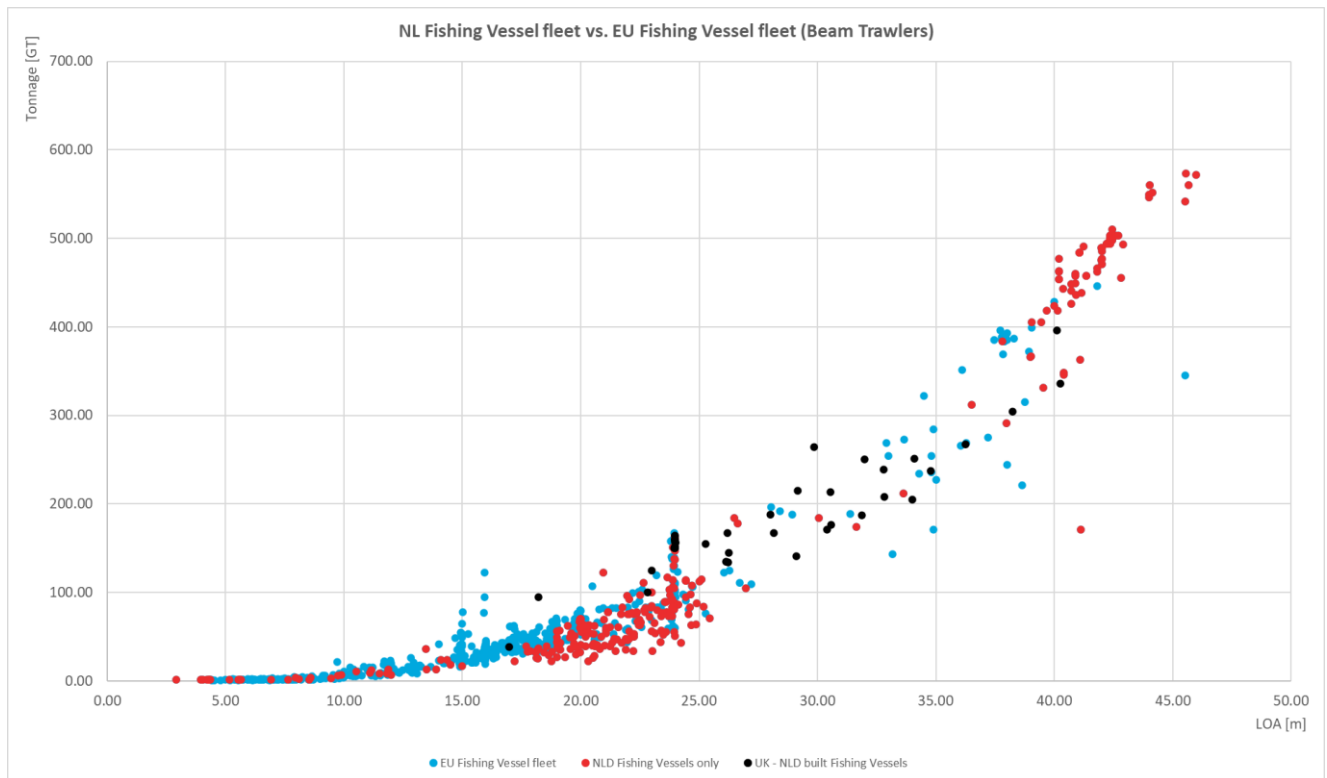
Figure 6: Dutch beam trawlers plotted in the total EU beam trawler fleet

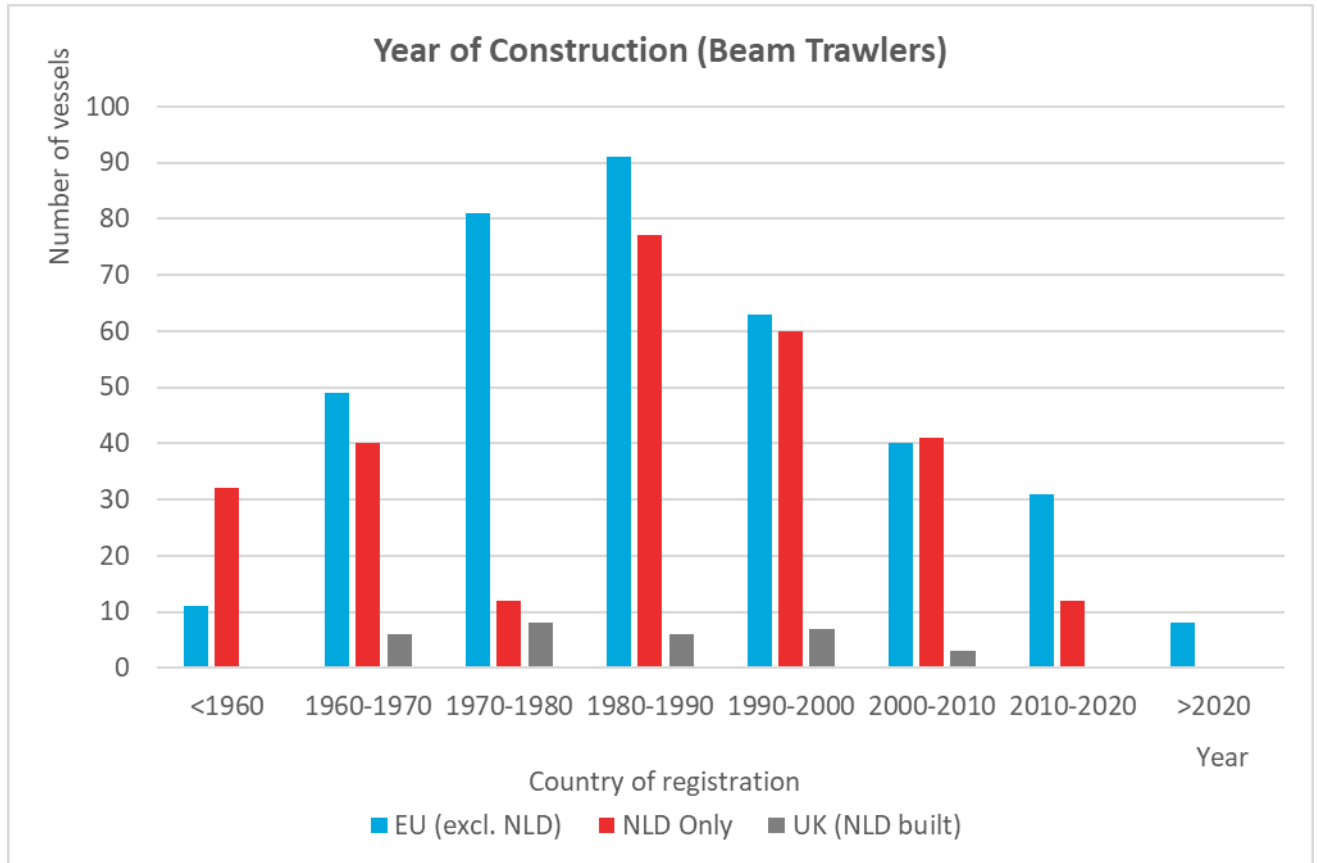
Conoship has a rich history of fishing vessels and beam trawlers designed and built, mainly from the late 1980's and early 1990's. It shows that in this period, only large beam trawlers were designed within the 2000 hp (1470 kW) limit.

Figure 7: Year of construction of Beam trawlers registered in the EU, NLD and UK

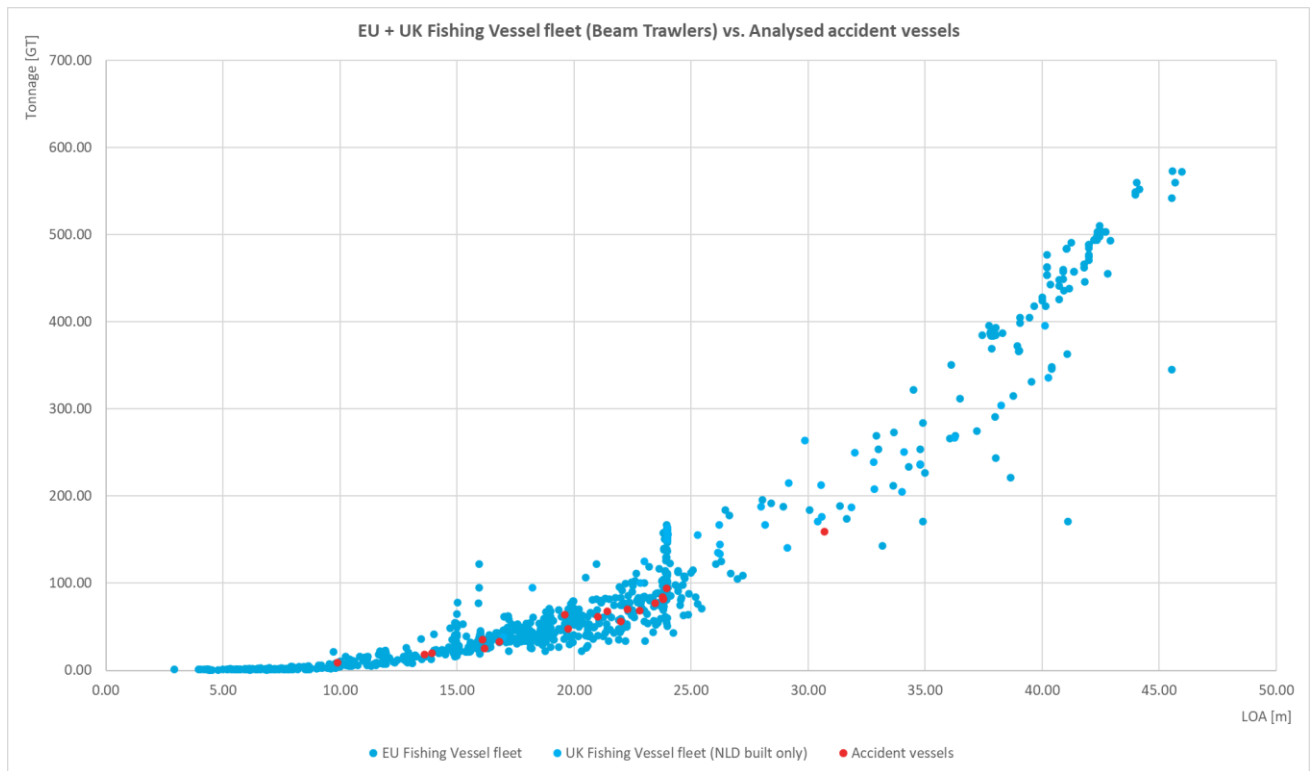
Figure 8: EU + UK Beam trawler fleet with the analyzed accident vessels plotted.

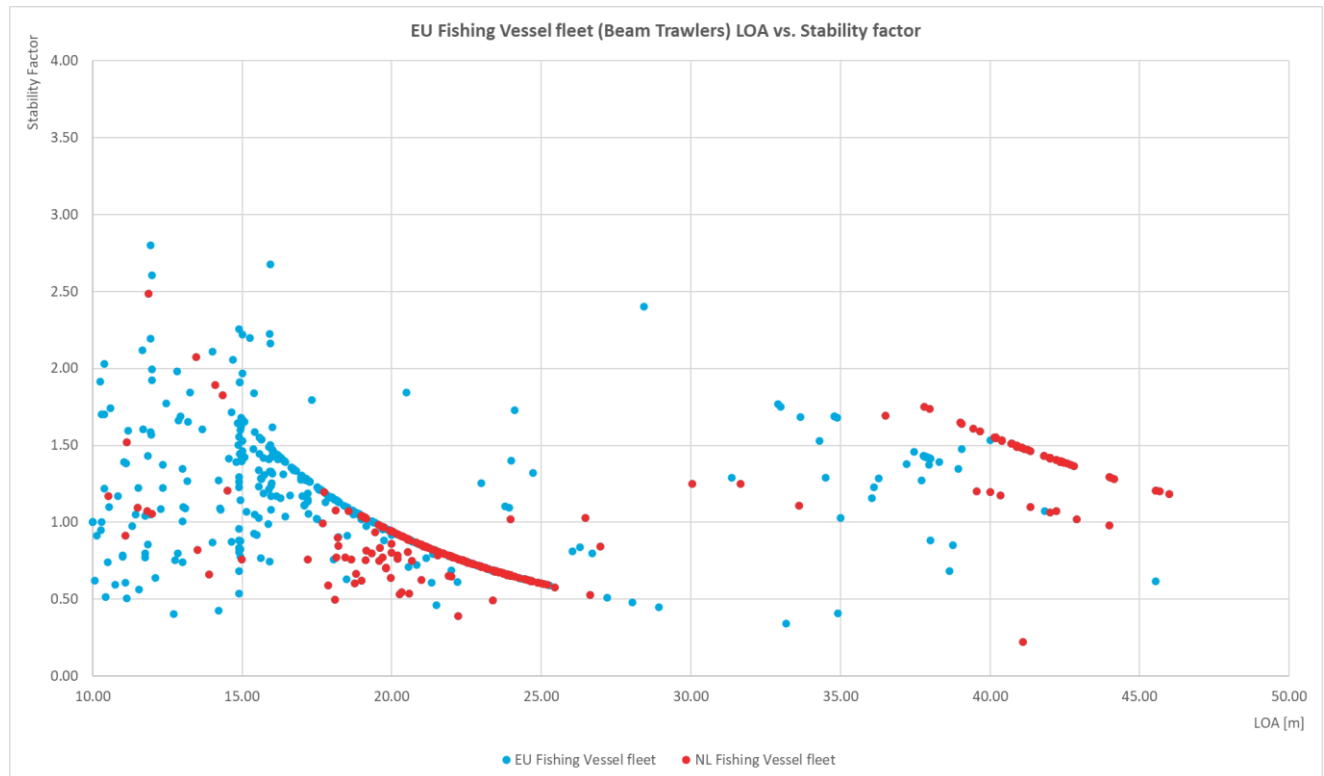
To identify the *stability factor* (introduced in chapter 4.1.2.1), and thereby the possible influence on the minimum applicable stability criteria, the stability factor is calculated for every vessel, and is plotted against LOA. See Figure 10.

Figure 10: Length over All plotted against stability factor for EU Beam Trawlers

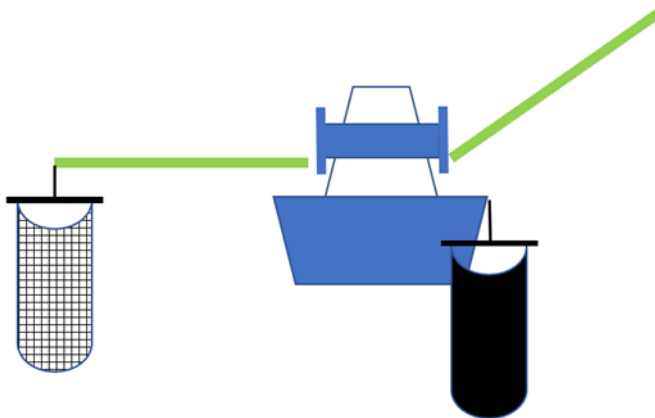
- External factors: Wind, waves, water on deck etc.;
- Internal factors: Position of the derricks, stern trawl gear on net drums or not, enlarged derricks;
- Loads on derricks, both symmetrical and asymmetrical: fishing gear empty, with catch, with debris, stuck to the ground, with functioning or not functioning safety system;
- Symmetrical loads on derricks: fishing gear in both derricks, empty, with catch, with debris, stuck to the ground, with functioning or not functioning safety system;
- Hauling catch: symmetrical or asymmetrical hauling of the cod-end of the net to deck for emptying;
- Fishing net to side of the vessel, of which an example is shown in Figure 11;

Figure 11: Fishing net to side of the vessel

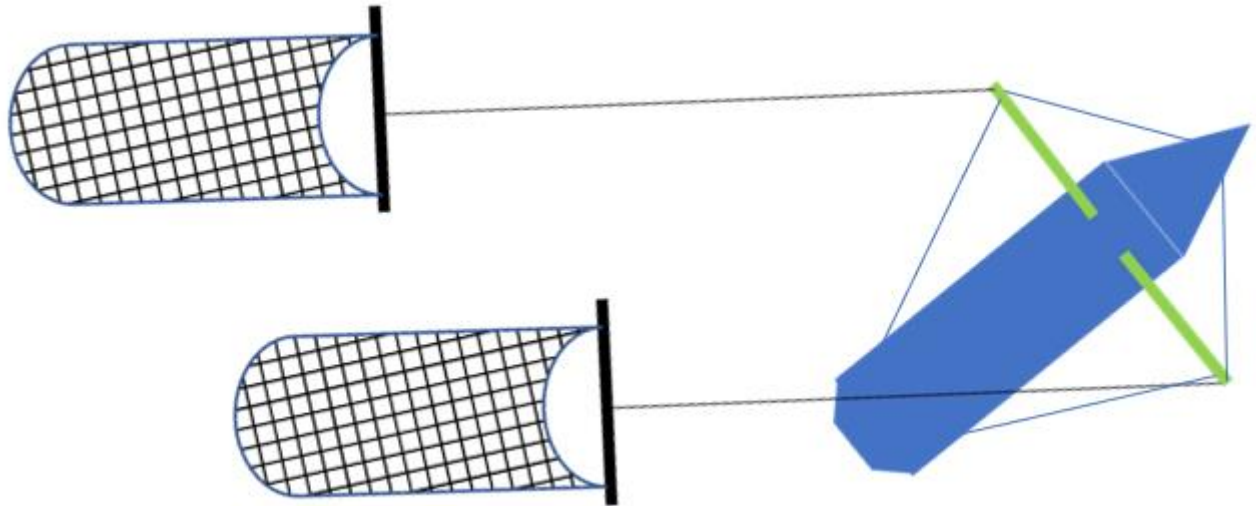
- The direction of the waves related to the vessel;
- The wind force, without and with gusts;
- A longitudinal wave with a wave length equal to the vessel's length;
- Water on deck;
- Switch of fishing gear to the other side, as shown in Figure 12;

Figure 12: Fishing gear switching to the other side of the vessel

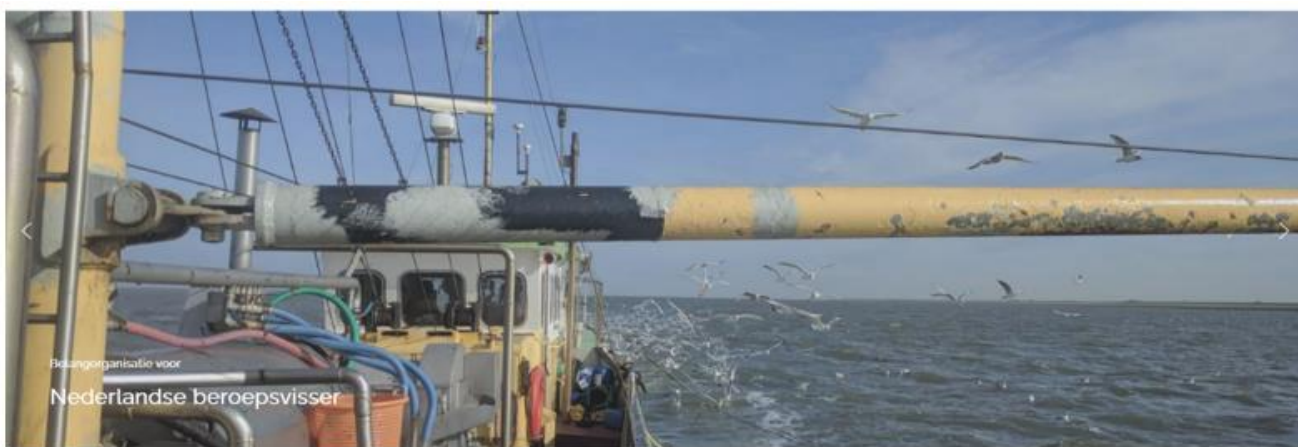
During interviews with inspectors of ILT and designers it became clear that derricks are regularly lengthened without updating the stability booklet. An example was found on the internet, showing a beam trawler with a clearly recently lengthened derrick.

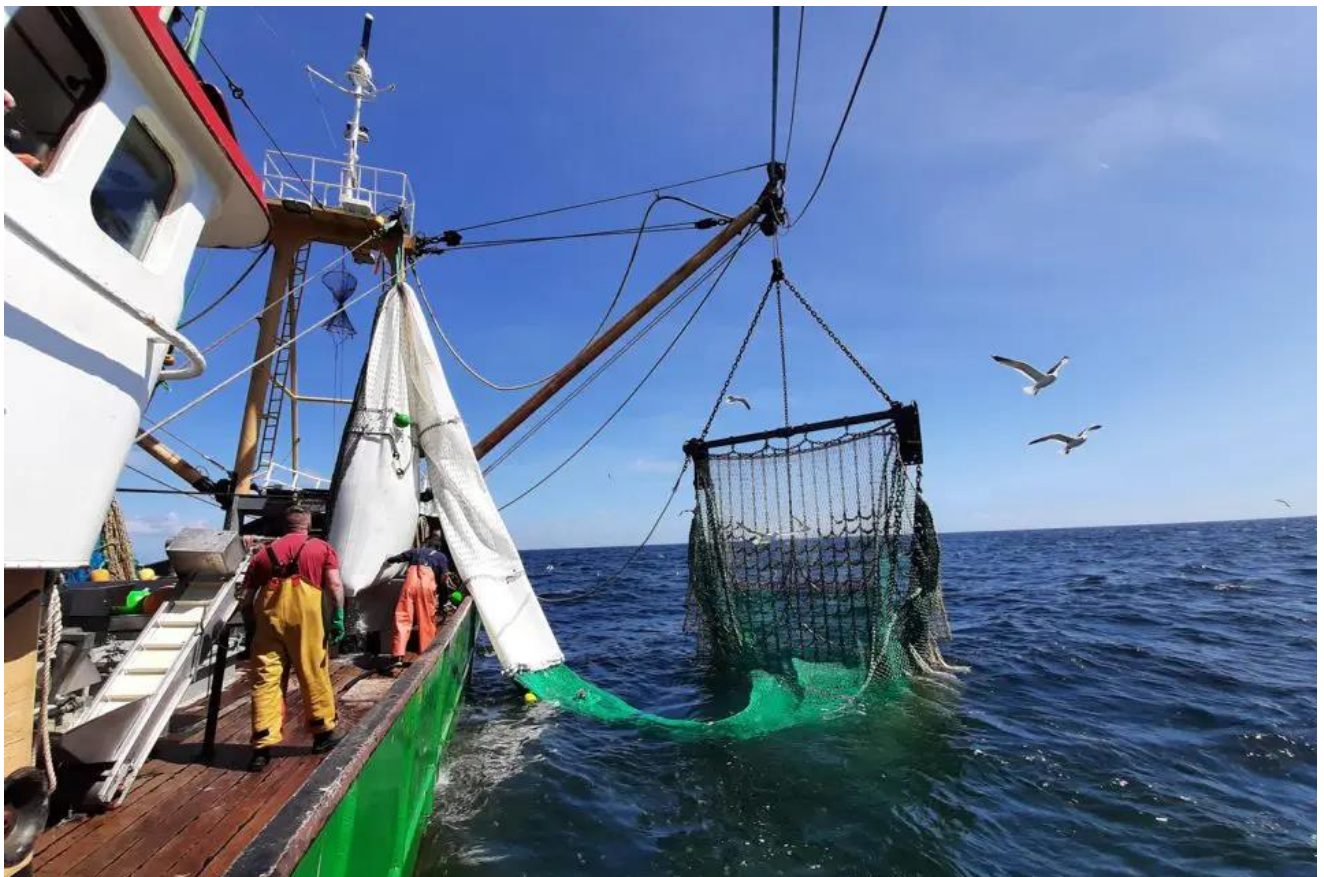
Figure 13: Hauling the cod-end of a net (picture source 'Globalseafood.org')

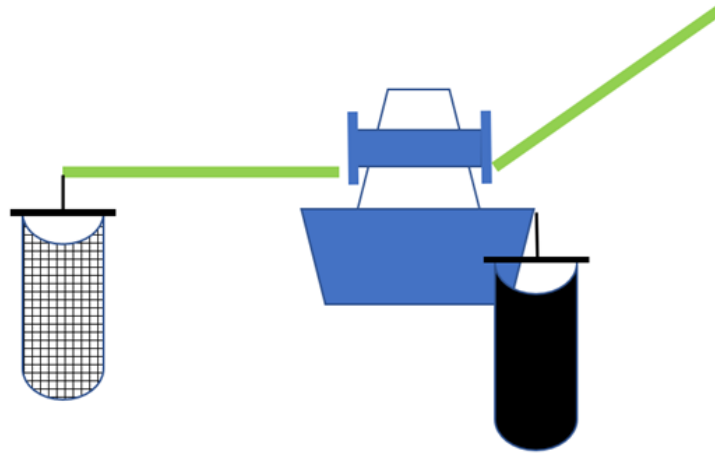
When a heavy load is detected in one or both nets, the safety system can be activated. This system lowers the fishing block from the top of the derrick to the side of the vessel, thus drastically reducing the heeling moment acting on the vessel.

Figure 14: Fishing net lowered to the side of the vessel

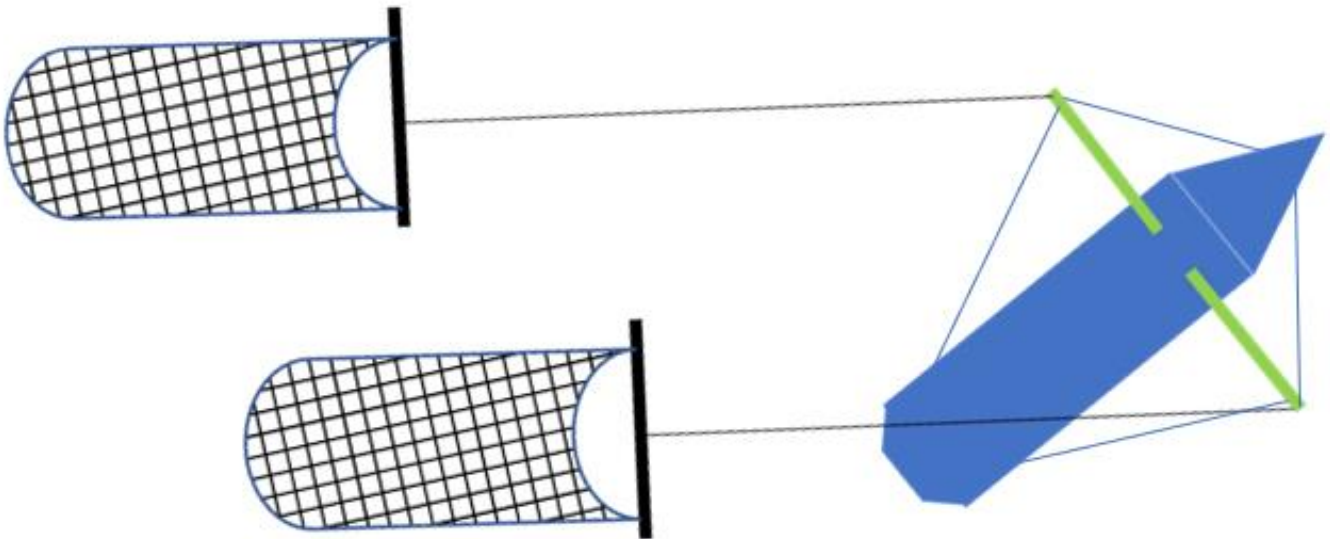
The impact on stability is high, although the occurrence is low. Mitigation is possible by regular maintenance of the engine and rudder systems. This results in relatively low risk ratings, as can be seen in Appendix XI.

Figure 15: Fishing vessel turning over the fishing line

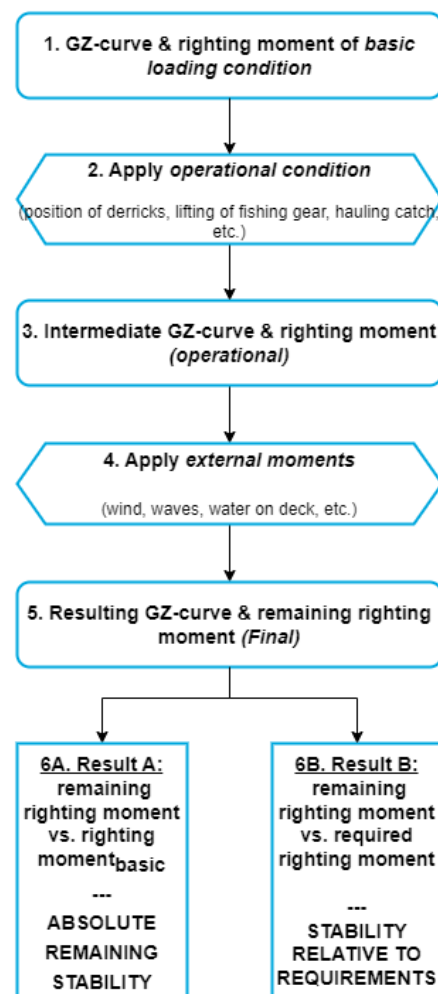
The calculation steps described above are elaborated in the following paragraphs. Details on the formulas used can also be found in Appendix XVII.

Figure 16: Flowchart showing the steps of the calculation method.

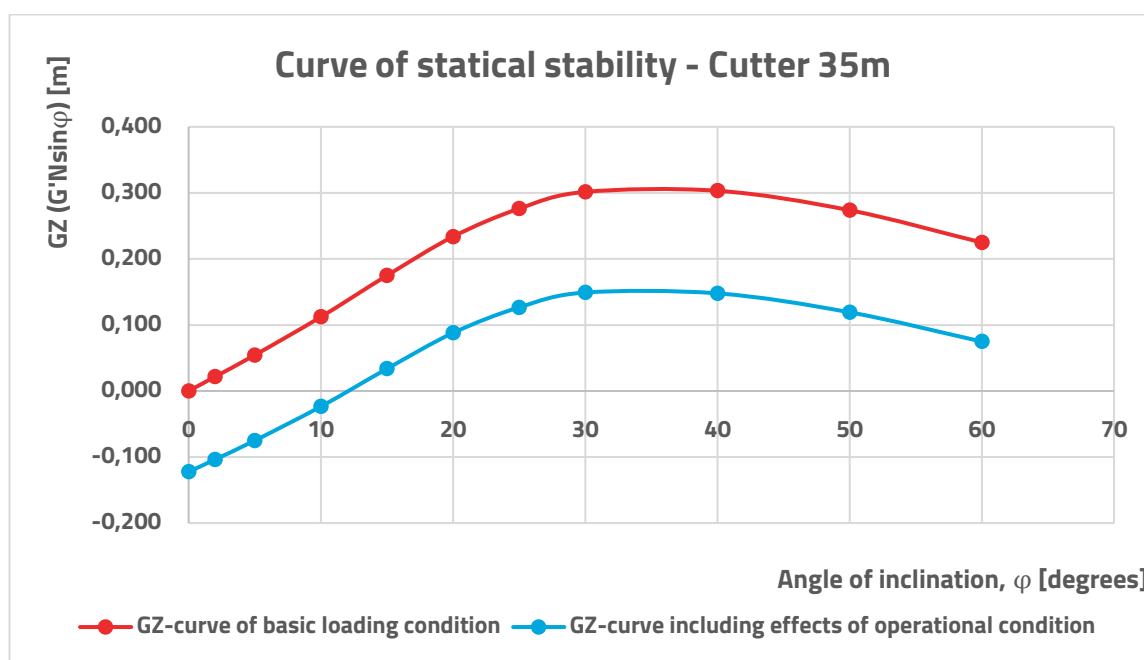
For each of these elements, the effect on the vessel's VCG and TCG is calculated and this results in a change in the stability of the vessel. Figure 17 shows an example in which the stability of the vessel with a specific operational condition is decreased compared to the basic loading condition.

Figure 17 GZ-curves showing the effect on stability of a certain operational condition.

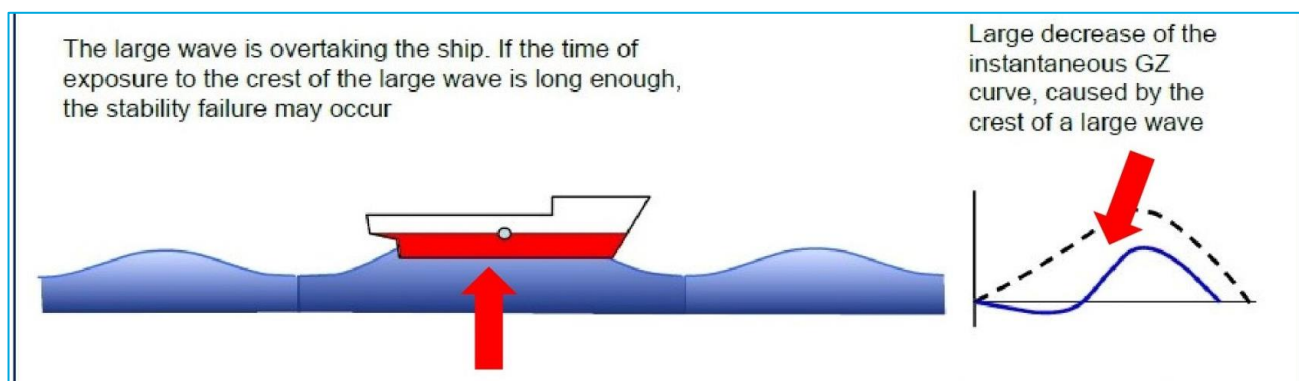
The most unfavorable wave considering waves in longitudinal direction are waves with a wavelength of about the length of the vessel and with the vessel lying on the wave crest. This situation is called *Pure Loss of Stability* and if the vessel is in such situation its stability can be dramatically decreased due to the decrease of waterplane area. This can lead to instant capsize of the vessel and is considered a high-risk situation (Gonzalez, Casas, Rojas, Agras, & Ocampo, 2015). This is especially the case when the vessel is sailing in following waves, what is often daily practice with beam trawlers. See Figure 18 for an illustration of this phenomenon.

Figure 18: Illustration showing the possible effect of *pure loss of stability* in longitudinal waves. (Source: IMO SDC 7/INF.2\_26 November 2019, "FINALIZATION OF SECOND GENERATION INTACT STABILITY CRITERIA.....", ANNEX – "DRAFT CONSOLIDATED EXPLANATORY NOTES OF INTERIM GUIDELINES ON SECOND GENERATION INTACT STABILITY CRITERIA", page 27)

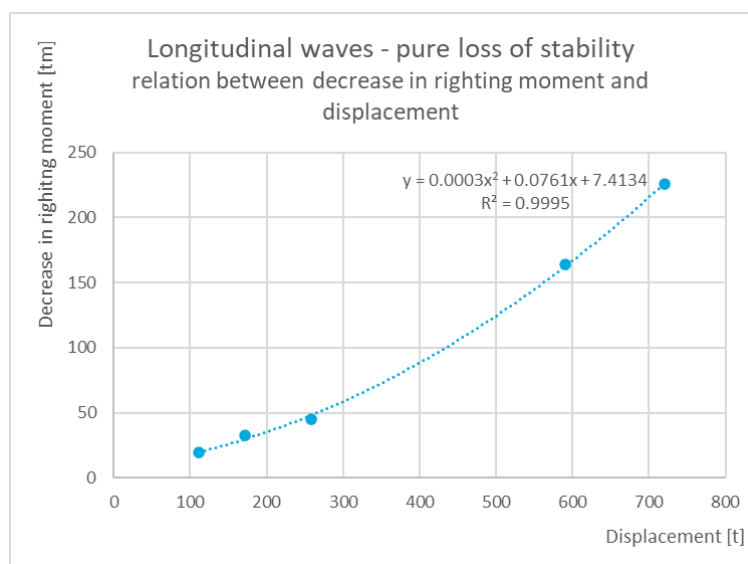
Based on a number of reference ships, and a calculation of the most unfavorable, but actually occurring, wave steepness in the North Sea, the *decrease in righting moment* was determined by means of PIAS. The result was a decrease of stability between 60% and 90%. A relation was found between displacement and the decrease in righting moment. These results were then translated into a general formula, which was used in the calculation model. The trendline and formula are shown in Figure 19.

Figure 19: Relation between decrease in righting moment and displacement for a vessel in a longitudinal wave crest.

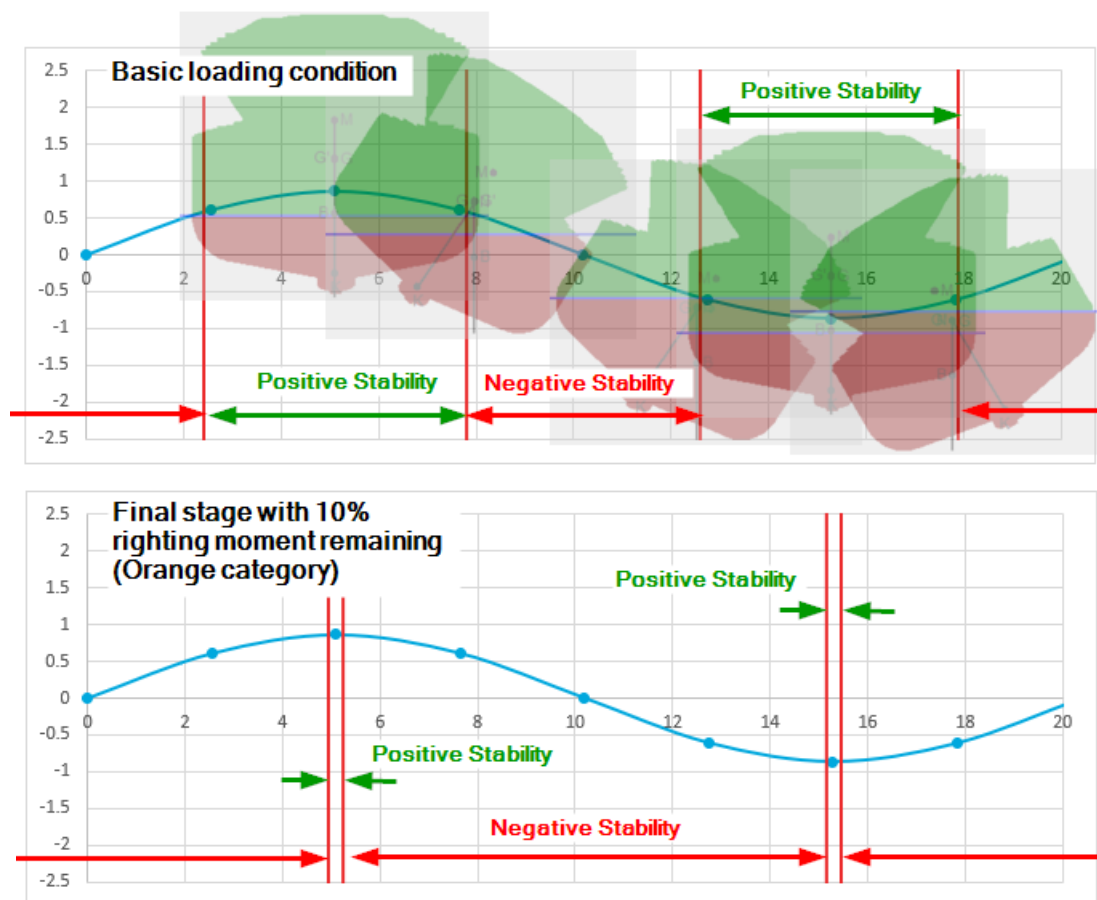
This shows that with a decrease in stability due to operational condition and/or external moments, vessels can be very vulnerable to capsize in transverse waves. The effect of the fishing gear in the water could not be included in this calculation but is considerable. Therefore, it has been chosen to include transverse waves in the qualitative analysis; in the FMEA-analysis (see chapter 7).

Figure 20: Example calculation of vessel stability in transverse waves (statical). A decrease in stability can make a vessel very vulnerable to capsize in transverse waves

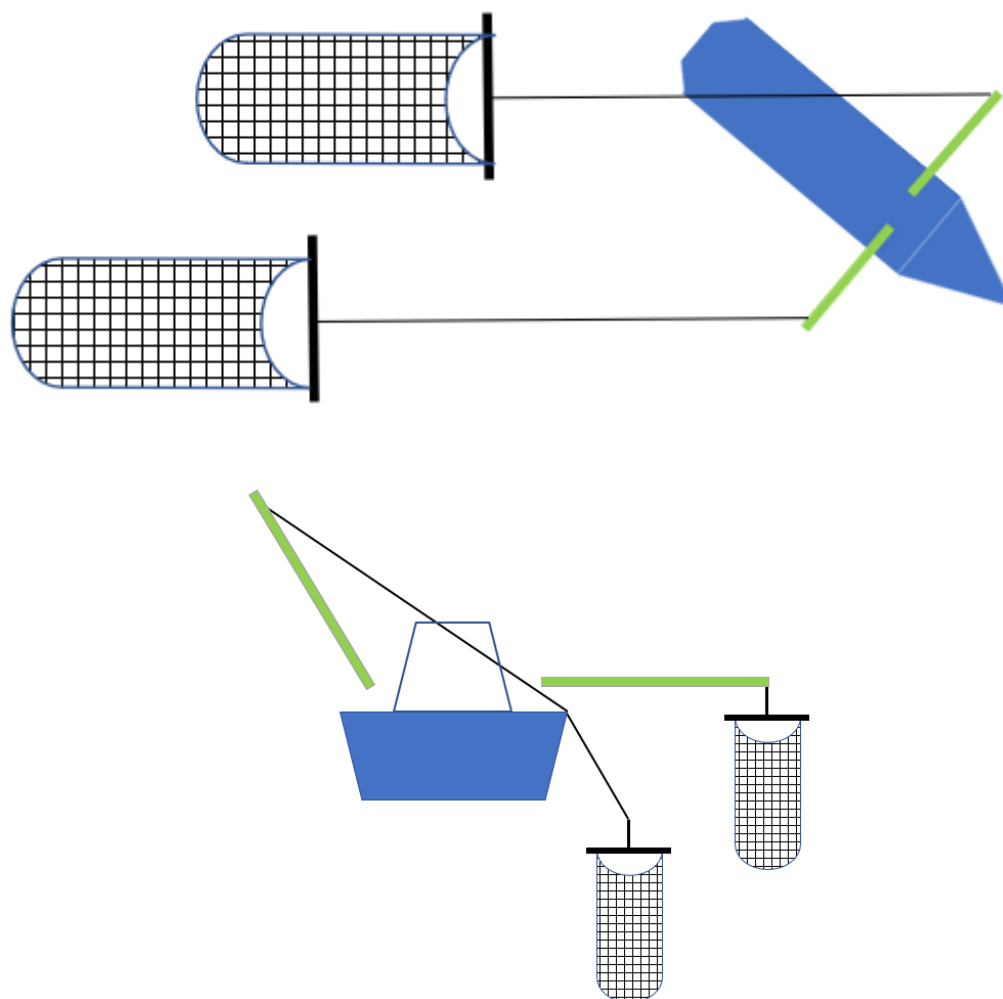
This option is illustrating the event of fishing gear plus any catch at PS skipping over to SB and then acting at SB-side. Either by the 'fishing wire' pulling underneath or overhead of the vessel in an event where the vessel is (uncontrollably) turning. After talking to fishermen, it became clear that many of them have experienced this event, where the fishing line of one of the nets flipped over or underneath the aftship. Figure 21 shows this situation.

Figure 21: Gear skipped to SB-side

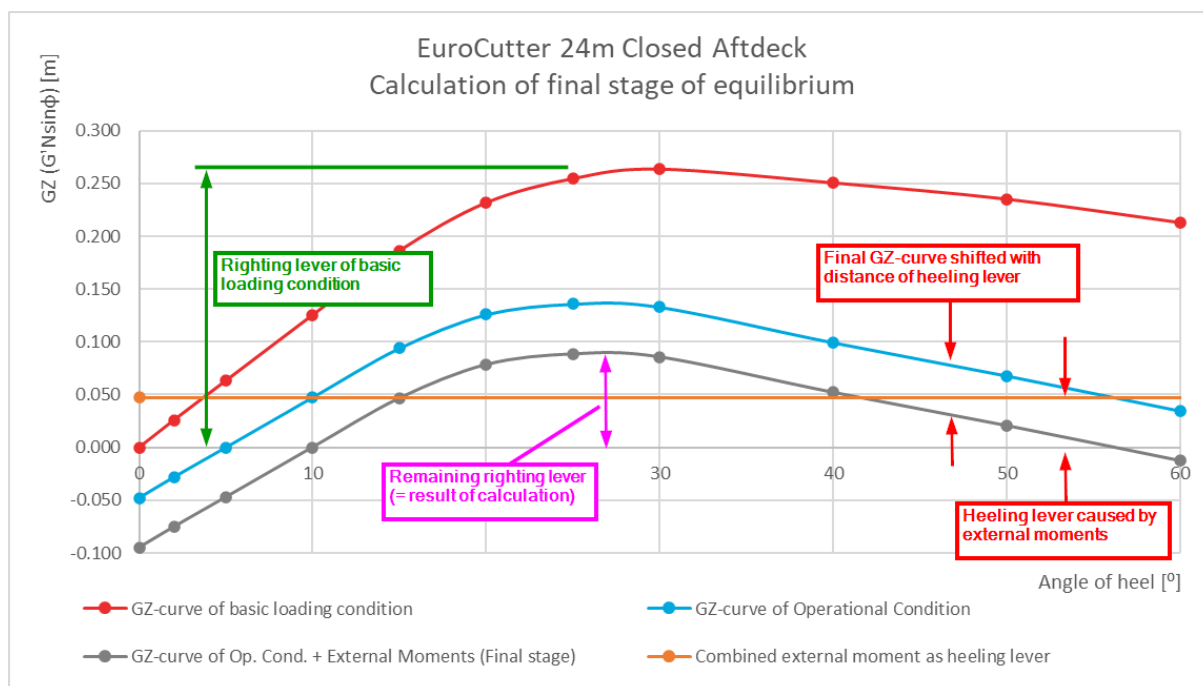
Therefore, the GZ-curve of *basic loading condition + operational condition* is updated with the effects of the applied external heeling moments by subtracting the lever of the total external heeling moments from the GZ-values. This is illustrated in Figure 22 below.

Figure 22: Different parts of the calculation of stability of combination of operational condition and external moments.

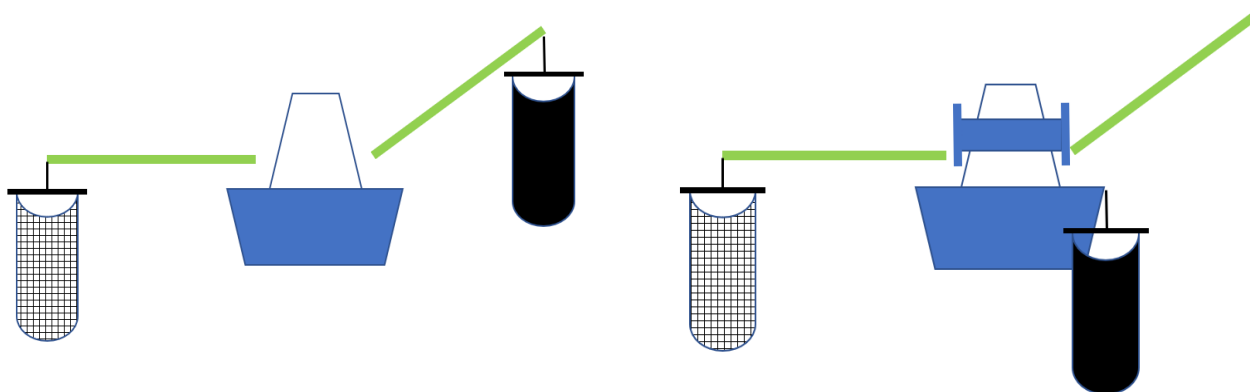
In Figure 23 examples are given for two of the codes. The codes for the situations observed for this investigation are given in Appendix IV. Codes for the external factors like wind and waves are given in Appendix V.

Figure 23: Situation with code 0045-BDP-NDS (PS derrick horizontal with empty net, SB derrick at 45 degrees and debris) and code 0045-BDP-NDS-GRD1-BBS-STG (PS net empty, SB safety system activated: net with debris lowered to the side of the vessel and Stern Trawl Gear stored on net drums)

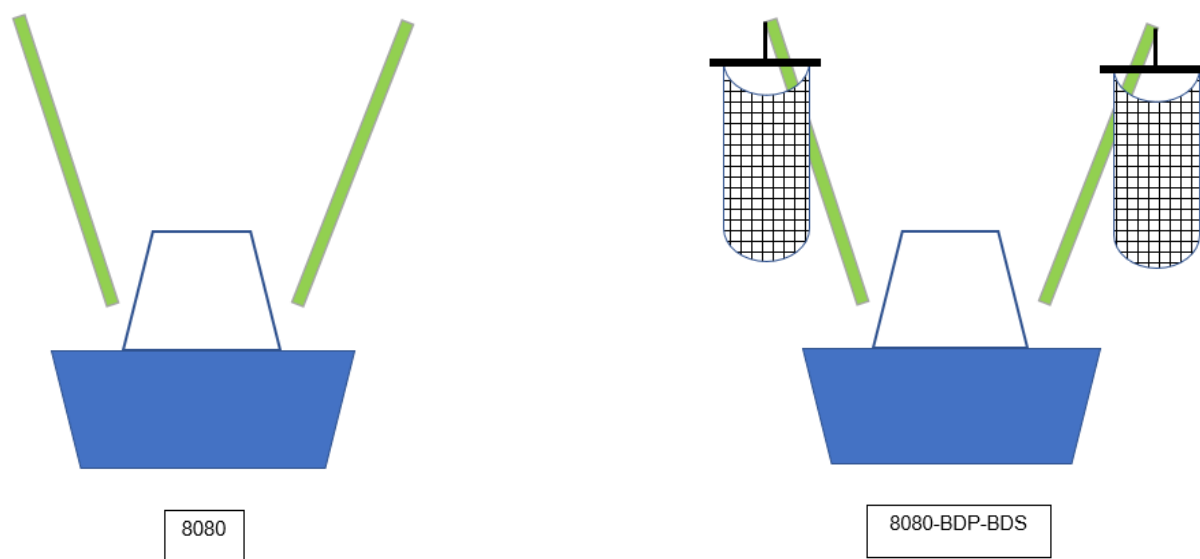
To determine the set of conditions, that could be used in the calculations of the remaining heeling moment for each vessel, a risk rating matrix was made with combinations of internal and external factors, the 'hard factors' as mentioned in chapter 9.1.1. These factors were used to calculate the stability of all vessels included in the investigation, as can be seen in chapter 8. Examples of observed fishing conditions, with their codes, are given in Figure 24 and Figure 25. Condition 8080 is the basic condition, 8080-BDP-BDS is the basic condition with nets hoisted from deck, suspended from the derricks.

Figure 24: Combined situations for fishing conditions with codes 8080: Derricks fully topped in transit position and 8080-BDP-BDS: Same situation, with fishing gear hoisted free from deck

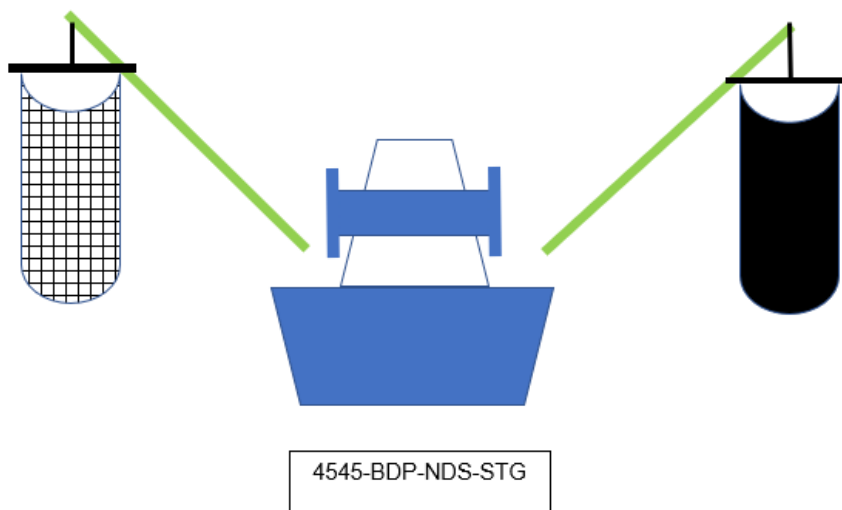
Figure 25: Explanation of code 4545-BDP-NDS-STG

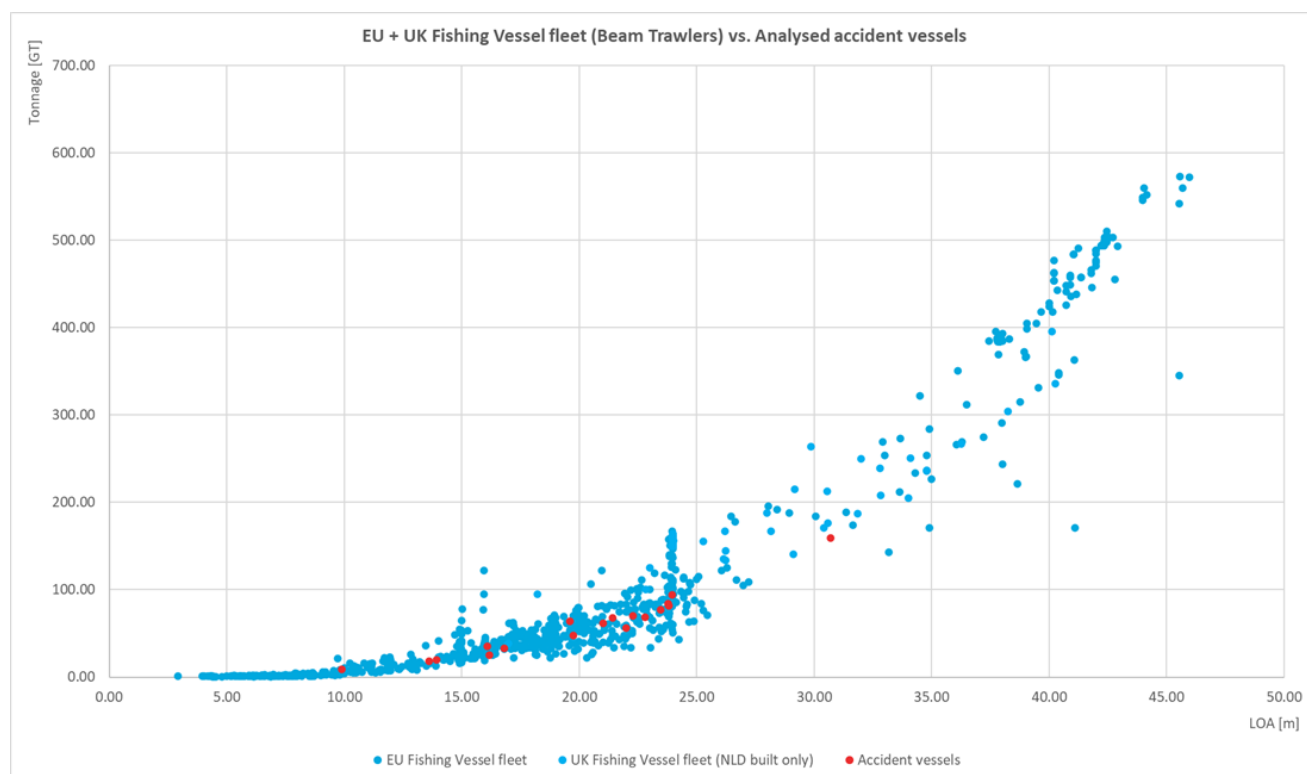
Except for one vessel, all investigated capsizing accidents happened to beam trawlers of 24 m or less, as can be seen in Figure 26. See also chapter 3.

Figure 26: Accident vessels compared to the entire beam trawler fleet

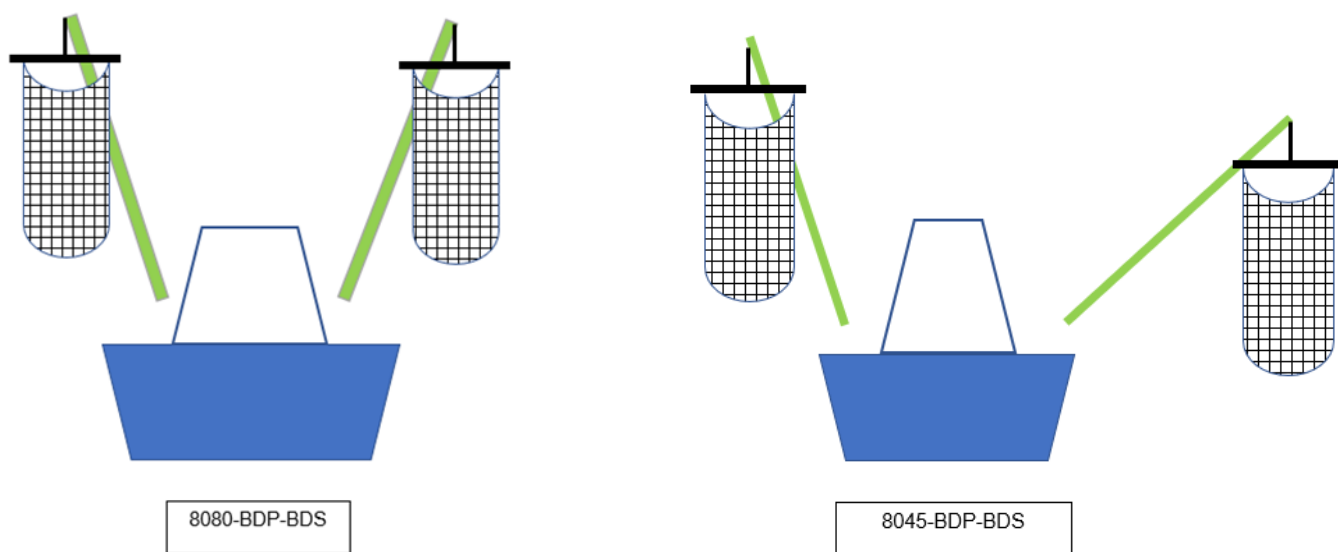
For the investigation the remaining righting moment for various asymmetrical conditions were calculated. For example: When fishing starts, both fishing gears are hoisted in the derricks, in the 8080-BDP-BDS condition. Then one of the derricks is lowered to 45 degrees, creating an asymmetrical condition with empty nets. Figure 27 shows both situations.

Figure 27: Sketches of the first stages of fishing

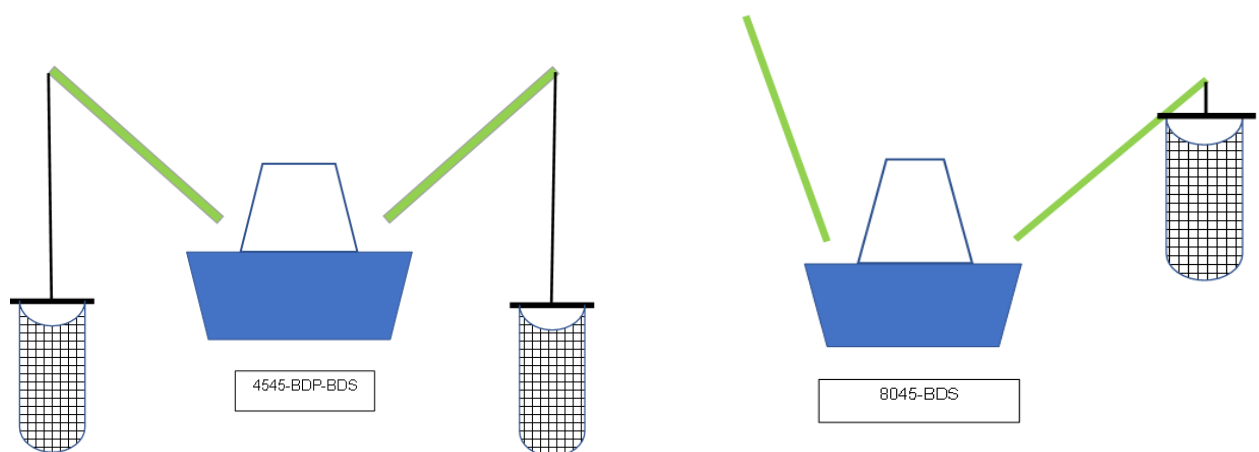
As part of this investigation, the remaining righting moments for the vessels when one fishing gear is lost, while the other remains at the end of its derrick, have been calculated. In the observed situation the PS fishing gear was lost, resulting in the derrick moving to the upright condition as shown in Figure 28.

Figure 28: The effect of losing one fishing gear

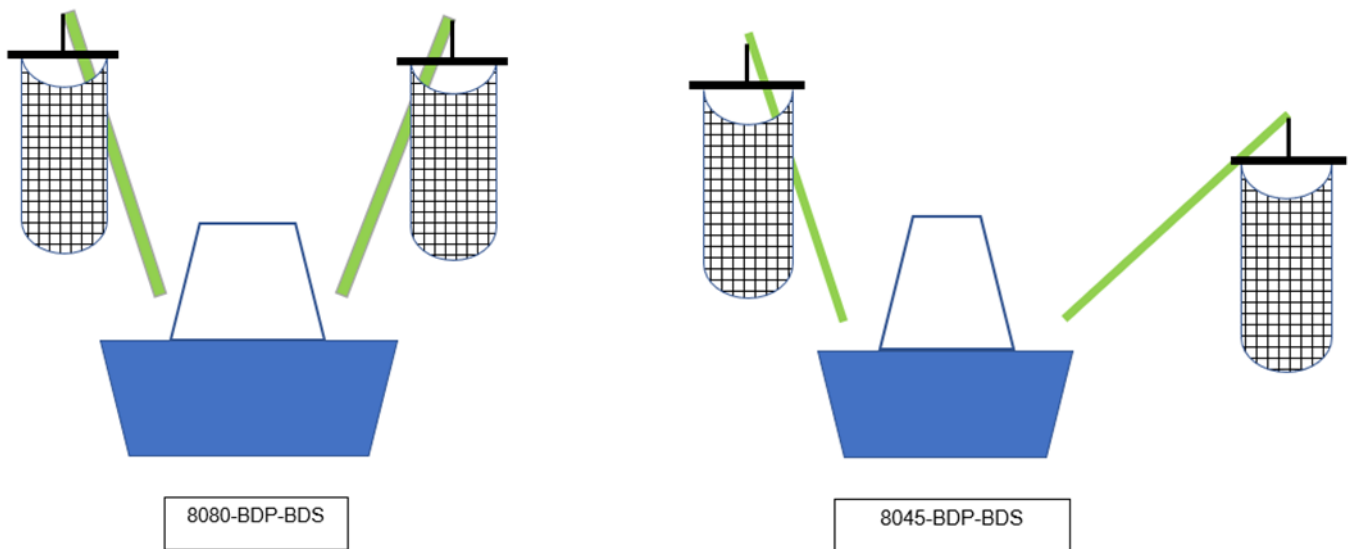
- Without any influence from wind or waves the stability with empty nets in both derricks is reduced by 25 – 67% for the vessels in the investigation, when one derrick is lowered to 45 degrees shown in the sketch below.
