# Stability of beam trawlers

RC22C003-1999-rev04

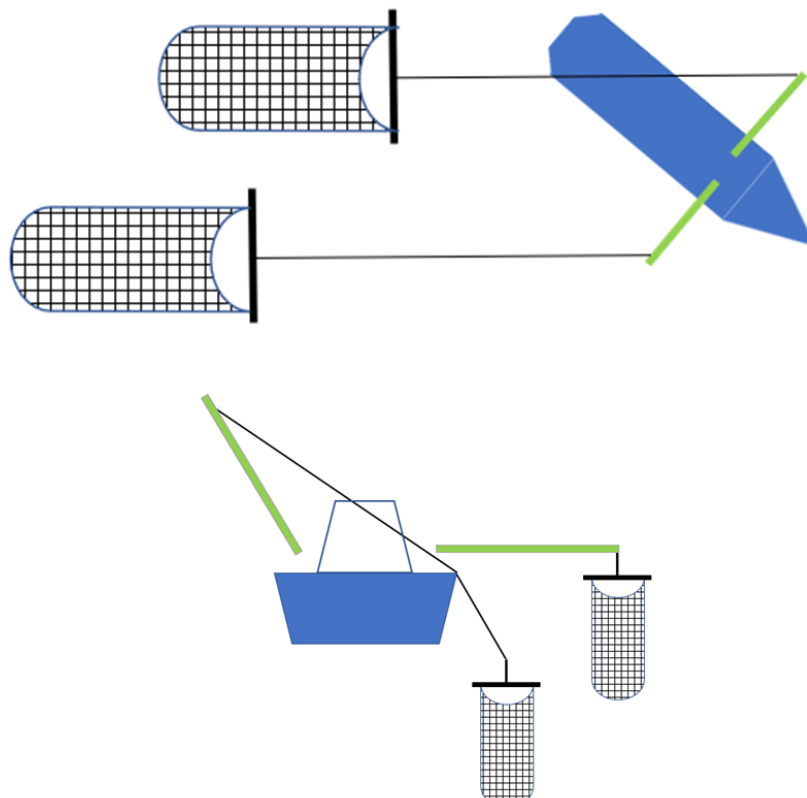
- A heavy load in one net reduces the remaining righting moment considerably, especially with both derricks at 45 degrees. Then all vessels < 24 m have in most conditions little till no remaining righting moment. In that situation a wind with a force of 6 Bft. will reduce the remaining righting moment to a dangerous level. In this situation a well-functioning (automatic) safety system can be a life-saver.
- The danger of one fishing gear skipping over to the other side (Figure 29) is obvious from the score cards: In most of the operating conditions the vessels have no remaining righting moment.

Figure 29: One net skipping over to the other side

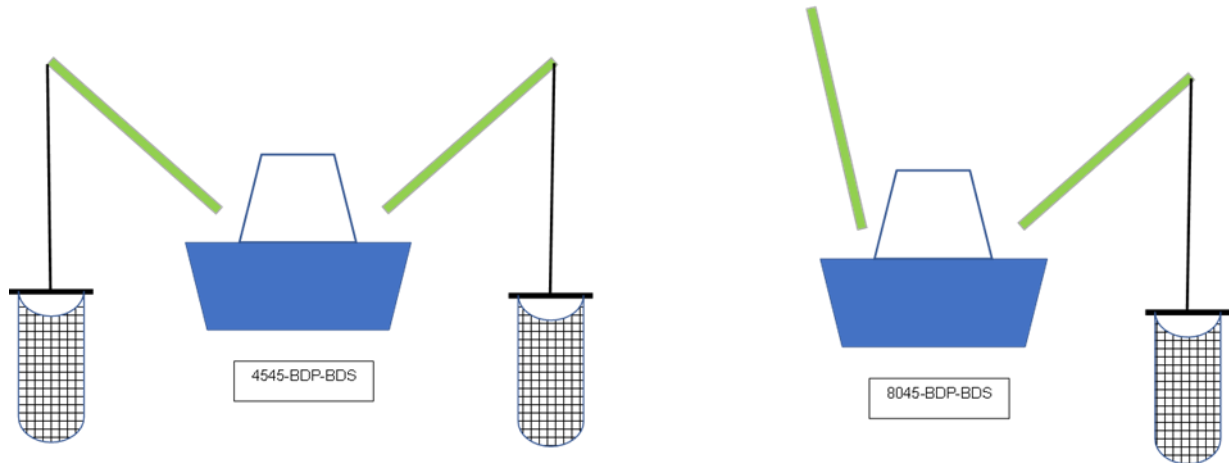
The remaining righting moments were calculated for all vessels in the investigation for the situation given in Figure 31. The remaining righting moments decreased by 20 – 30% for the beam trawlers < 24 m and 11 – 22% for the beam trawlers > 24 m. The EuroCutters are much more vulnerable to this phenomenon. The calculations show only the results on the static stability, but there is a significant dynamic effect as well. This effect could not be quantified with the calculation methods used and needs more research.

Figure 31: Loss of the PS fishing gear

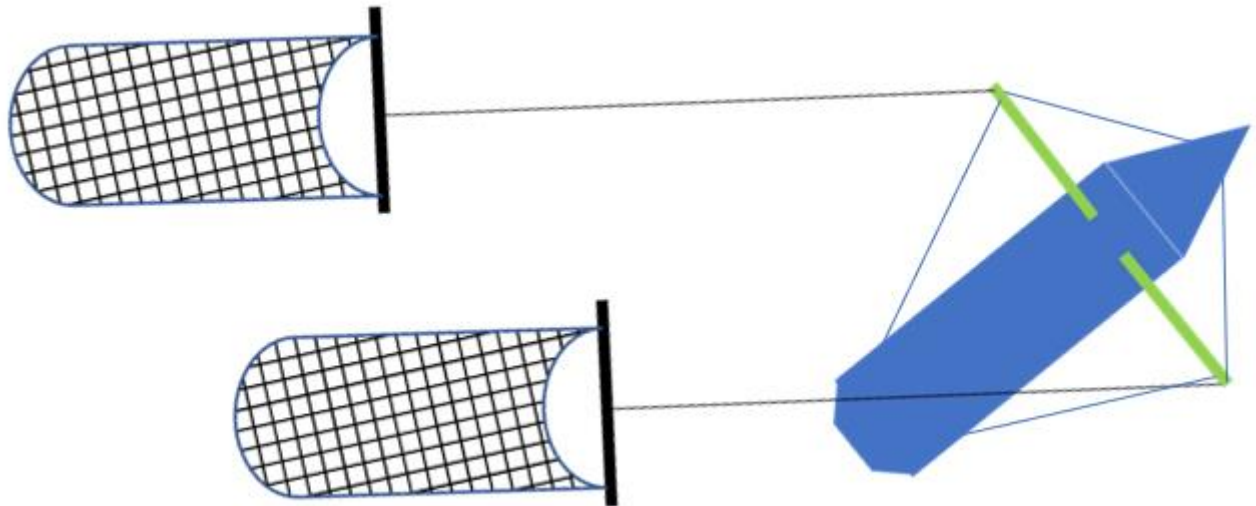
The risk of a net skipping to the other side of the vessel, as shown in Figure 32 is serious and mitigation is difficult, because of the combination of vessel's speed and course related to the waves and the current. Training of students and crew, preferably in a bridge simulator, will help by acknowledging the risk and mitigating the risk.

Figure 32: Fishing net skipping to the other side of the vessel

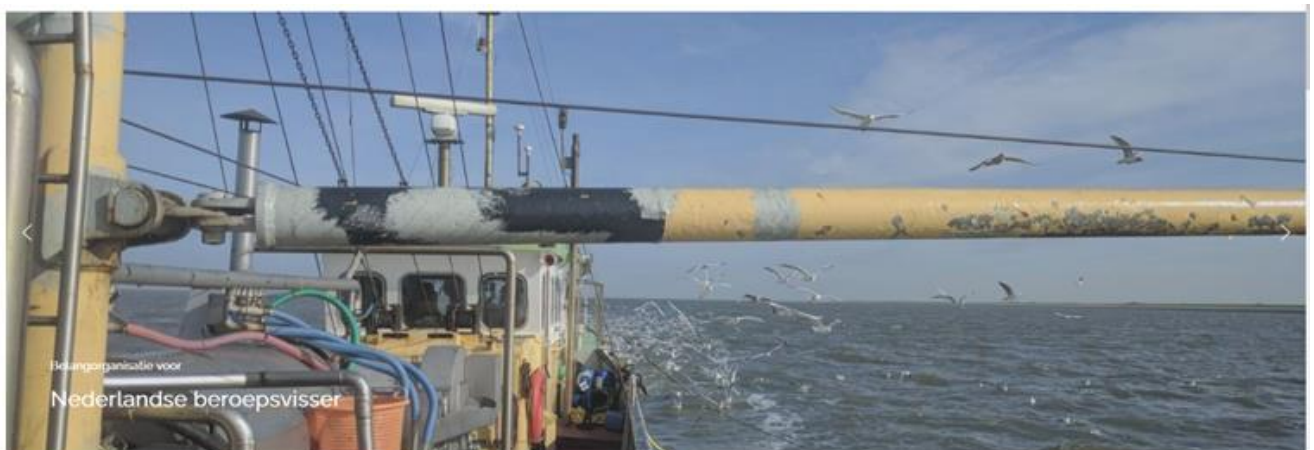
When a fishing gear is changed, the derricks are sometimes lengthened. An example is given in the picture below. Not always the stability information is updated for the derricks. Also, the effect of the longer derricks on the fishing conditions is not considered at all. Fishing conditions are not part of the stability information available to the master in the stability booklet.

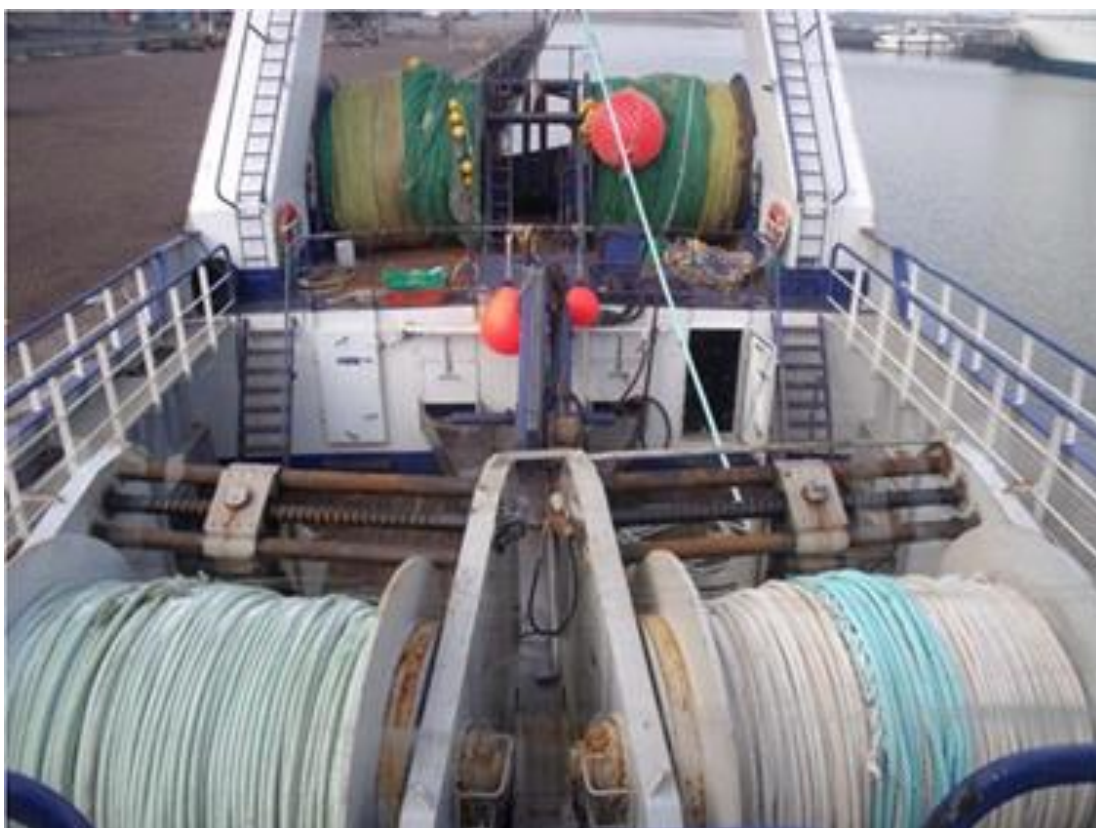
Often a combination of two fishing methods is used on a beam trawler: beam trawling and stern trawling (e.g. Twin rigging, Flyshooting) are alternated. When the vessel is beam trawling, the stern trawl gear is stored on net drums on the aftship, (Figure 33) or left ashore. The storage of the stern trawl gear is a topic mentioned in the stability booklet: For most vessels this gear must be removed when beam trawling and in some cases even the net drums have to be removed. This is not always done. Report on the capsizing and sinking of fishing vessels (Dutch Safety Board, 2021).

Figure 33: Stern trawl gear on the net drums

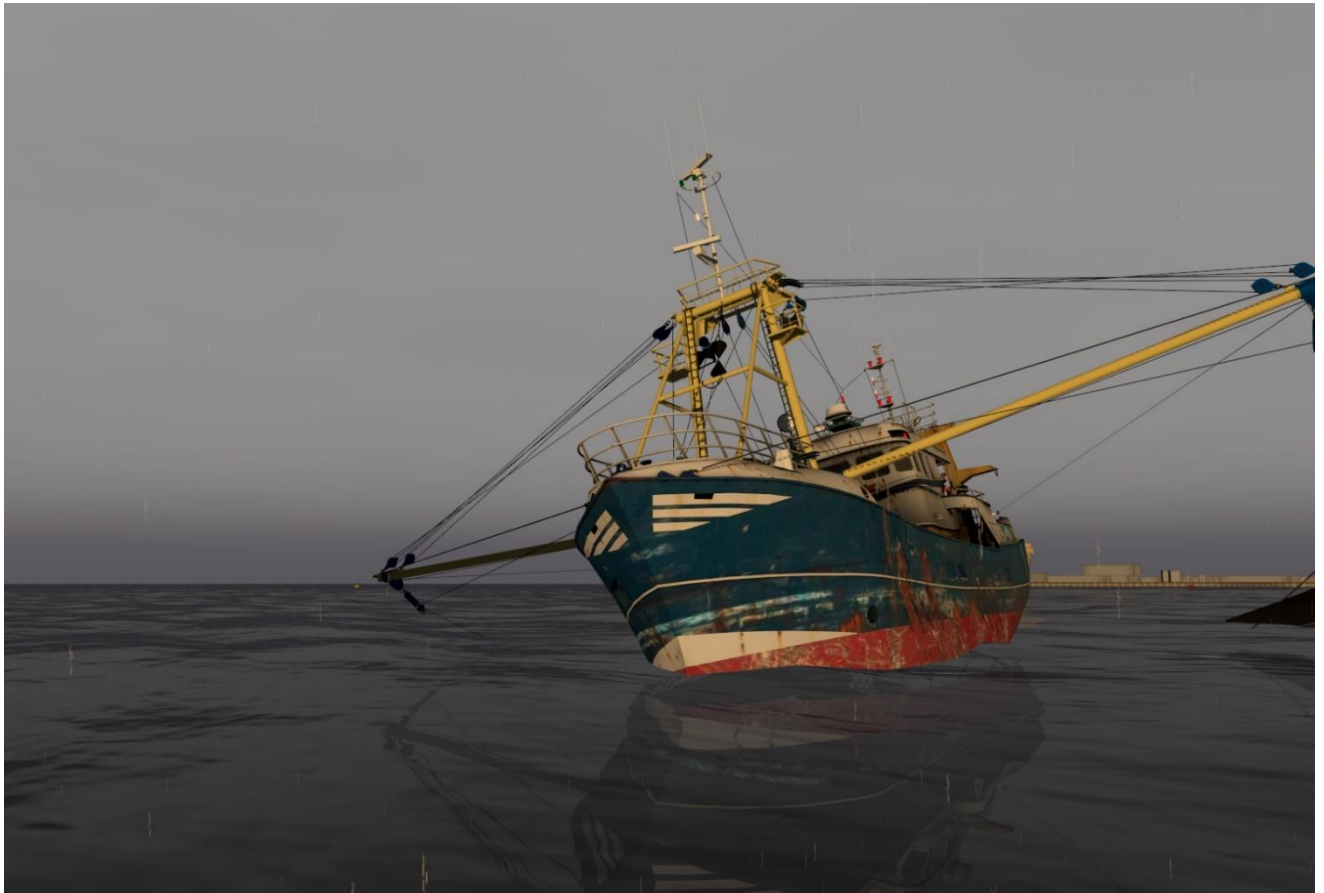
At this moment there is no bridge simulator that is able to fully show the effects of the fishing operations. However, MARIN is developing a bridge simulator, in which fishing conditions can be simulated, including the effects of changing derrick positions. Figure 34 shows a screenshot of the simulator.

Figure 34: Screenshot of the MARIN-simulator

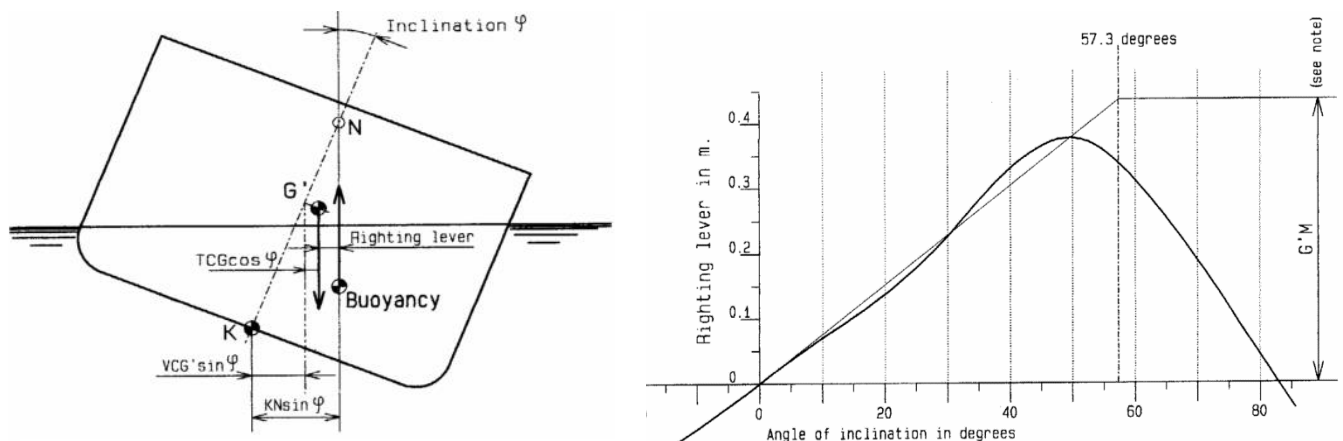
For a better understanding, Figure 36 shows these parameters (left) and the GZ-curve (right)

Figure 36: Parameters used in calculation of GZ (righting lever) [left] and GZ-curve [right]

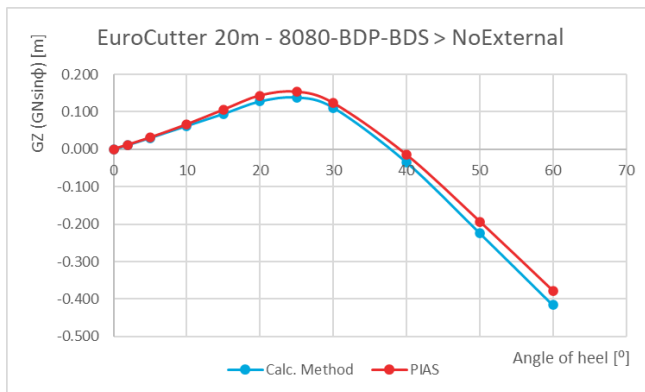
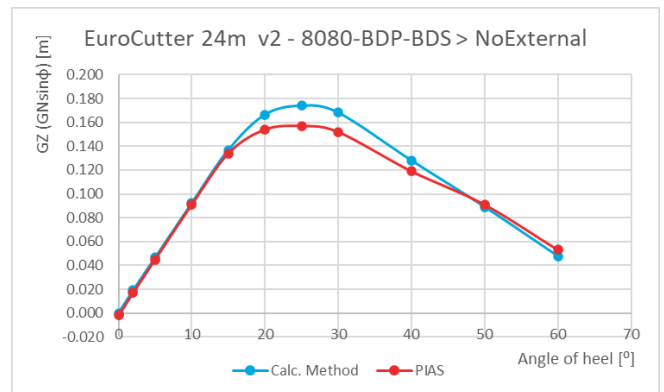
EuroCutter 20m		EuroCutter 24m v2 (Closed Aft deck)	
Operational condition	8080-BDP-BDS		8080-BDP-BDS	
External moments	NoExternal		NoExternal	
	Calc. Method	PIAS	Calc. Method	PIAS
Resulting Displacement	111.3	111.3	257.9	257.9
Resulting VCG'	2.820	2.820	3.034	3.033
Resulting TCG	0.000	0.000	0.000	0.000
Resulting GM'	0.348	0.348	0.534	0.534
External moment	No	No	No	No
Resulting Max. GZ	0.138	0.153	0.174	0.157
Resulting angle of heel	0.0	0.0	0.0	0.0
Remaining Righting Moment	15.4	17.4	44.9	40.5

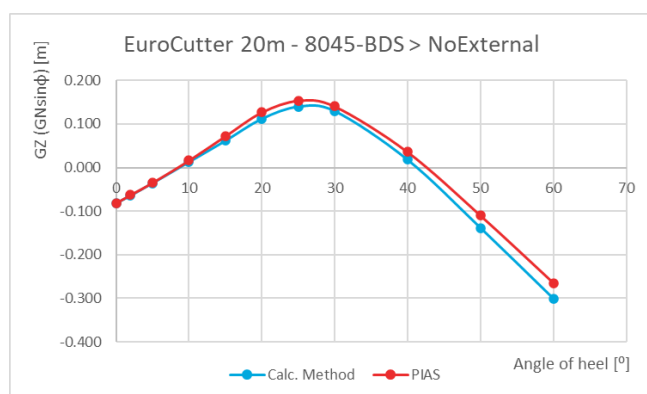
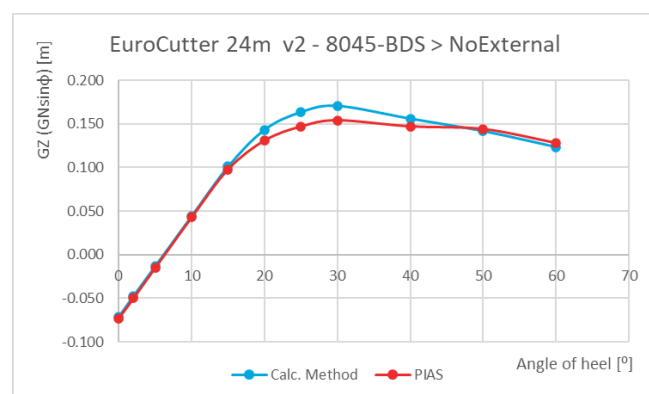
EuroCutter 20m		EuroCutter 24m v2 (Closed Aft deck)	
Operational condition	8045- BDS		8045- BDS	
External moments	NoExternal		NoExternal	
	Calc. Method	PIAS	Calc. Method	PIAS
Resulting Displacement	111.3	111.3	257.9	257.9
Resulting VCG'	2.640	2.642	2.905	2.905
Resulting TCG	0.082	0.082	0.0710	0.0730
Resulting GM'	0.528	0.526	0.660	0.663
External moment	No	No	No	No
Resulting Max. GZ	0.140	0.154	0.171	0.154
Resulting angle of heel	8.7	8.5	6.2	6.3
Remaining Righting Moment	15.6	17.1	44.0	39.7

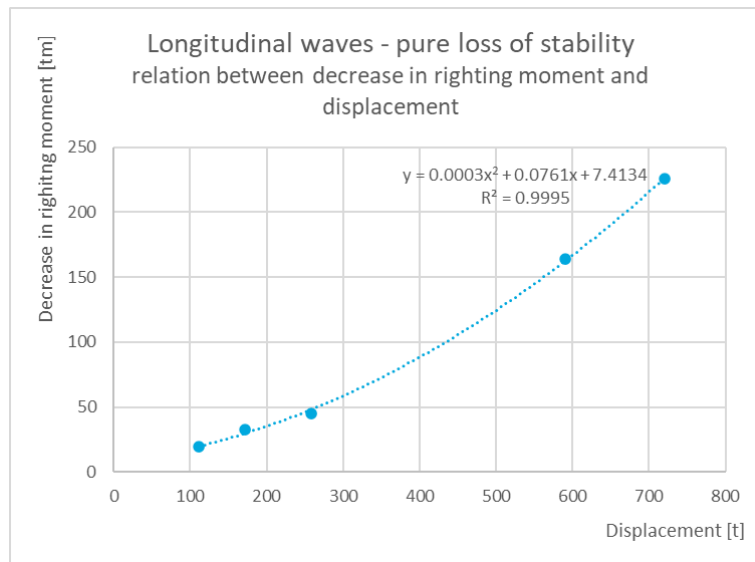
Figure 37: Relation between decrease in righting moment and displacement for a vessel in a longitudinal wave crest.
