# Mortierongeval Mali 2016

Heropening onderzoek 2022

*Den Haag, augustus 2022*

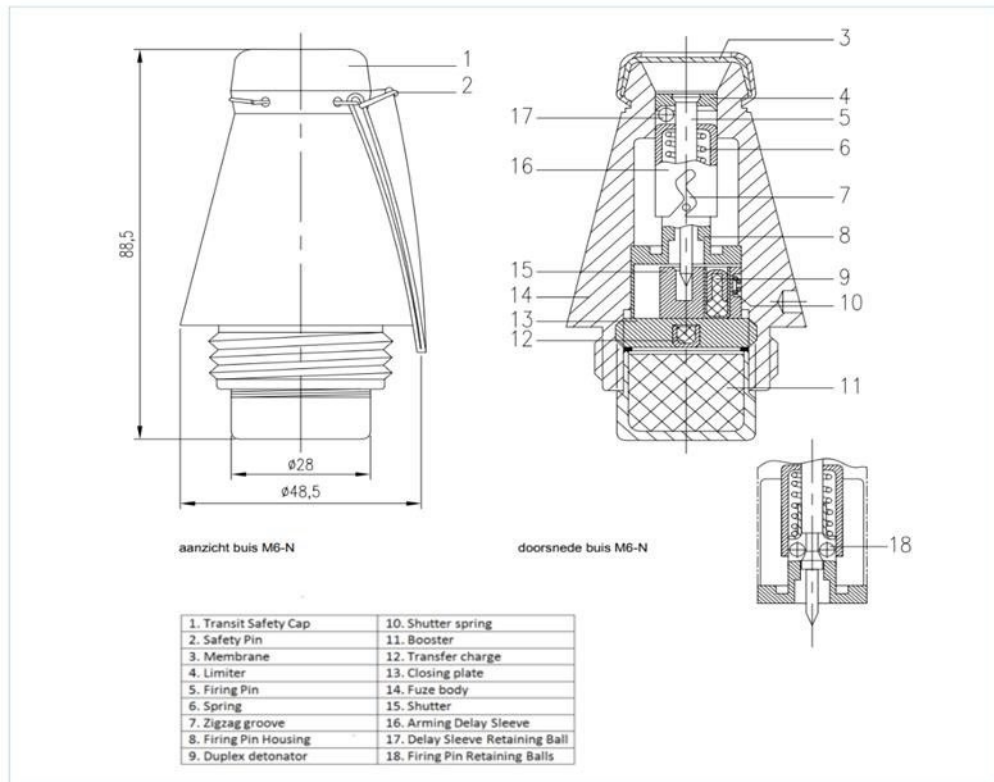
Figure 4: The M6-N fuze with detonator (9) in 'safe' position. (Source DSB Report [5])

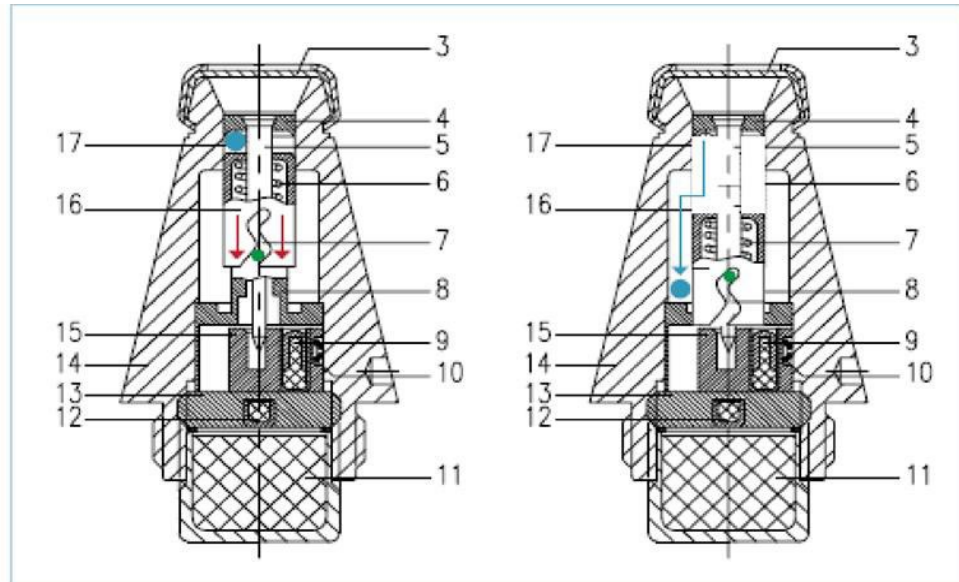
Figure 5: Position of the safety mechanism in the fuze at the moment before the acceleration begins, direction shown with red arrows (left) and at the end of acceleration at leaving the mortar tube (right). Cross pin (not numbered) shown in green. (Source: Ministry of Defence/TNO)

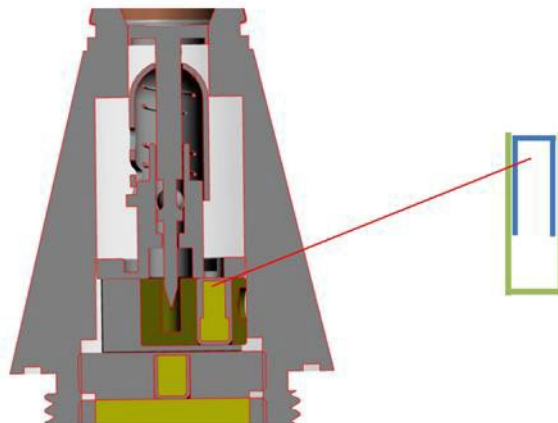
Figure 12: M6-N Fuze. The duplex detonator consists of two metal casings with one slid into the other. The inner casing that contains the energetic materials is made from aluminium. The outer metal casing is made from a copper-nickel metal alloy (Melchior). (Picture: TNO)

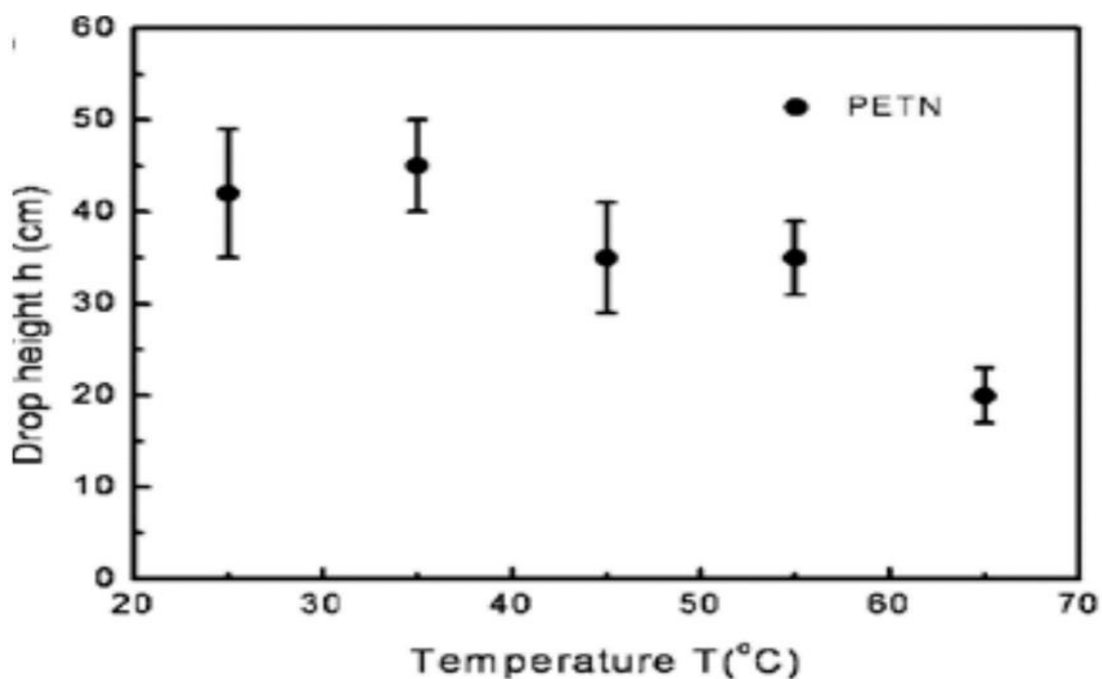
In addition to the effect of temperature on chemical reactions and explosive decomposition, there is another consideration with respect to the accident in Mali. That is, whether the high temperature of the accident round enabled the detonation of the TNT main charge by functioning elements of the explosive train which would not have enabled the full detonation at lower temperatures. This is described in the DSB report [5, Appendix H] and the figure reproduced as Figure 21:

Figure 21: 7 Drop height at which PETN reacts versus temperature [Zhang & Weeks, 2010]. Note large increase in sensitivity above 55°C. (Source: TNO)

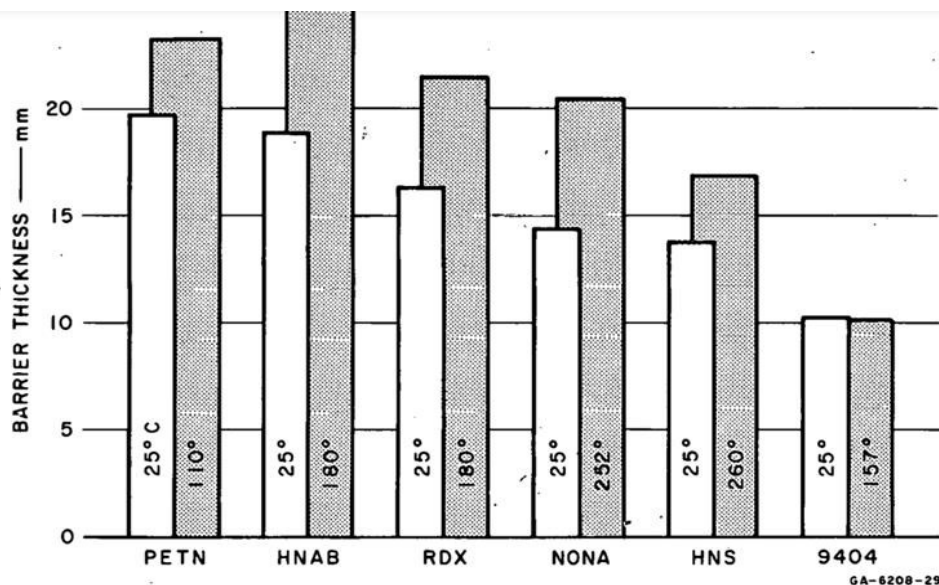
Figure 22 [15] used barrier thickness at which 50% go/no go detonative response is achieved at across a wide temperature range. The results, those for PETN and RDX, are both relevant to the HE 80, show very much lower temperature sensitisation even over a higher temperature range. There has been more recent work which, for RDX explosives, suggests shock sensitivity actually decreases in the range 25-110°C because of binder softening [16]. It is considered therefore that temperature is not a primary determinant of detonation susceptibility. If another, not directly temperature related factor, for example, the presence of initiating sensitizing sites (known as 'hot-spots') is dominant, the effect of increased temperature on explosive train functionality may be marginal. This observation is significant because attempts to reproduce the accident both at ambient (12°C) and elevated temperatures (70°C by TNO [5, Appendix J, Section 2] and 30 firings at 63°C by KC W&M [8, Section 4.7.3]) all failed to detonate the M6-N fuze booster and thereby would not function the main charge as actually occurred in the accident. This failure has been considered a cause to doubt the chemical mechanism proposed within the DSB report for the accident. The author would suggest that the explosives train functionality, particularly for the RDX/wax booster, may be significantly less sensitized by the temperatures experienced in Kidal and as suggested by Figure 21. These trials are considered in Section 6.9 below.

Figure 22: Shock Sensitivity of various explosives against temperature. Influence for PETN and RDX is of secondary order. (Source: Roth and Blackburn, 1967)

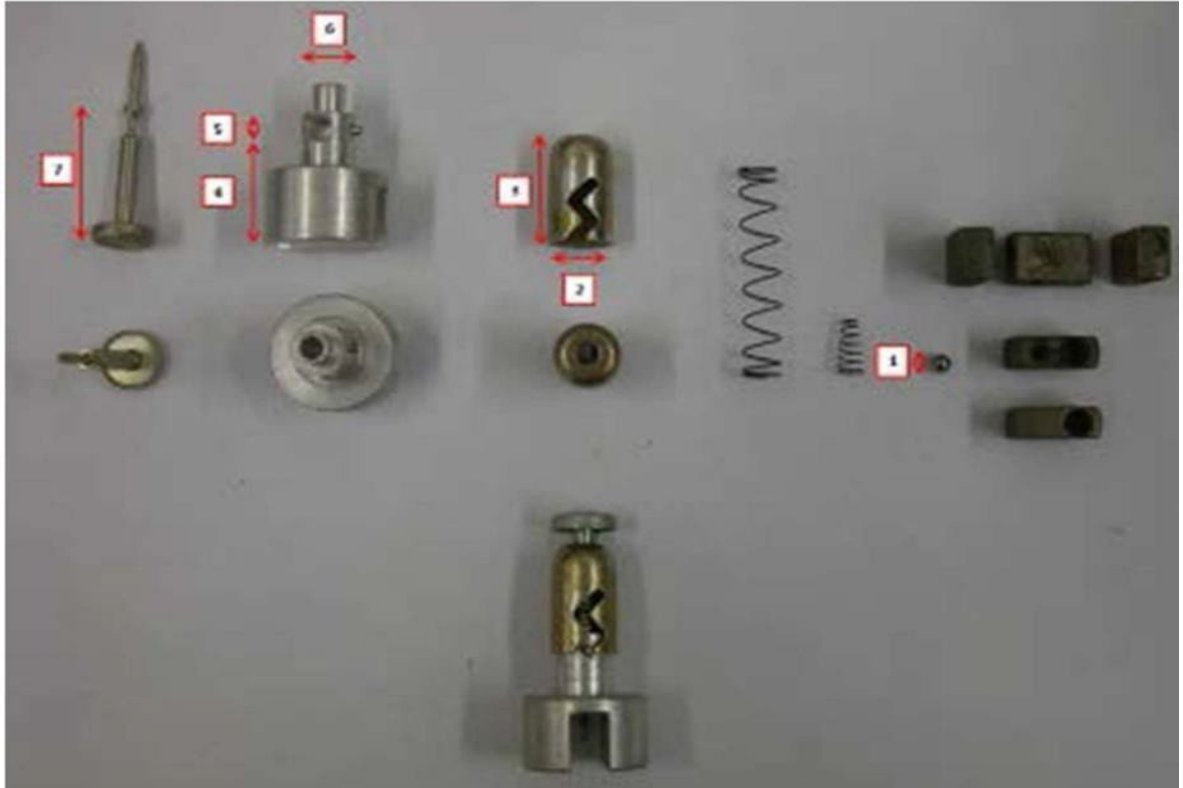
The report then provides a justification for this conclusion using measurements made of M6-N. In early 2018, 1,138 fuzes were disassembled in Gao and the components measured. Additionally, 140 fuzes were dismantled in The Netherlands (Section 6.1.5 refers). Figure 23 shows the breakdown of the components with indications of the measurements made. A total of 6460 measurements were made and the dataset analysed. KC W&M present their measurement of firing pin and non-return valve lengths as critical to the cause of the accident:

Figure 23: Fuse M6-N, Breakdown and dimensions measured by KC W&M. (Picture: KC W&M)

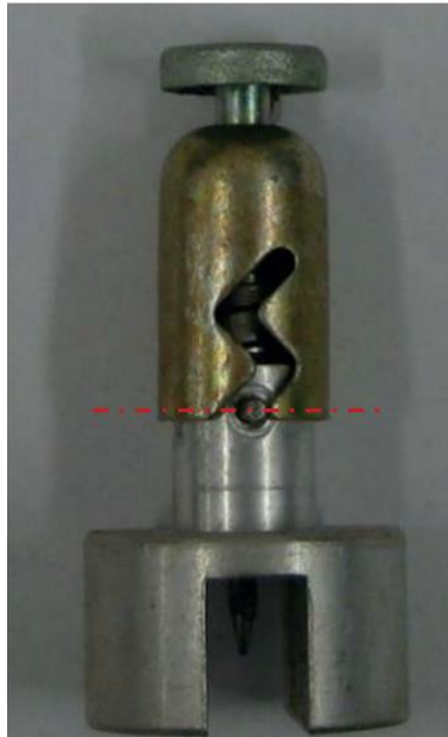
The components which control the 'safe/armed' status of the M6-N fuze are pictured in Figure 24. The centre line of the cross-pin is shown and it is the movement, following the zig-zag path, of the non-return valve down and up past this pin which should ensure arming is only possible after the HE80 round decelerates after launch and thus provides the safe separation distance. If a fuze build were possible where dimensional mismatch allowed the bottom of the non- return valve to sit above the cross-pin whilst still enabling the valve movement with respect to

Figure 24: M6-N fuze mechanism composed of correctly positioned zigzag cross-pin at the beginning of the first "knee" of the zigzag slot (Picture: TNO)

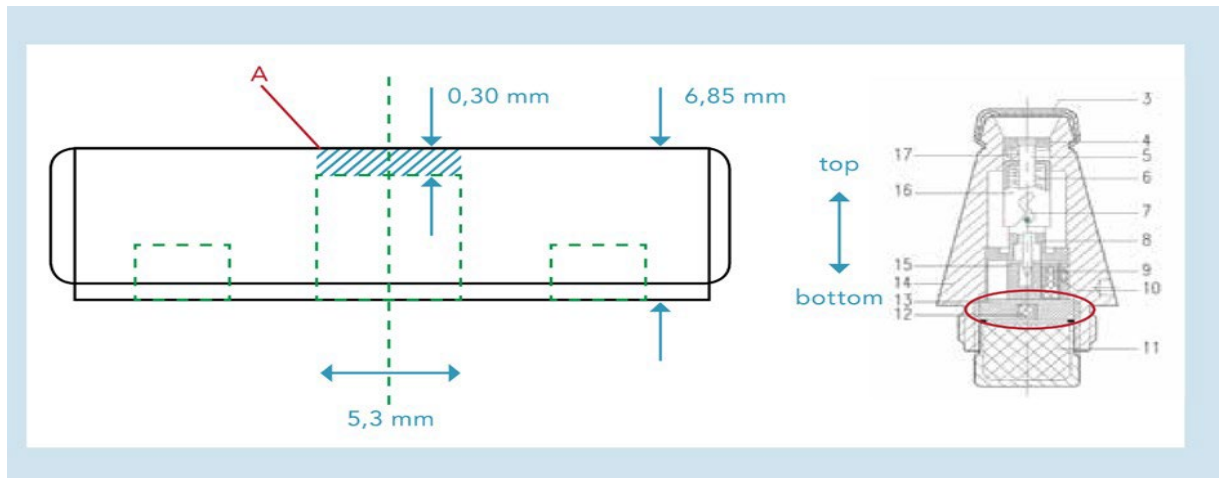
An additional factor is important in considering the interrupter plate evidence; both the safe position experiment and the accident evidence plates show the detonator actioning has caused the lead/transfer charge to react and the steel which was above this charge has been swept away. The interrupter plate is shown in section (in Figure 31) and, as shown in Figure 30, it can be seen that a 0.3 mm section has been lost. This is contrary to the design intent and the interrupter plate has failed in its function. In the DSB proposed mechanism, this enables a detonation of unstable copper azide, caused by launch set back shock, to be transmitted to the lead/transfer charge which, in turn led to the booster and main charge detonation. This aspect of the evidence is discussed in detail in Section 6.8 below.

Figure 31: Cross-section drawing of M6-N explosive train interrupter plate showing location of 0.3mm steel swept away in Figure 30 plates. Location of plate shown (circled red) on drawing, right hand side. (Source: TNO)

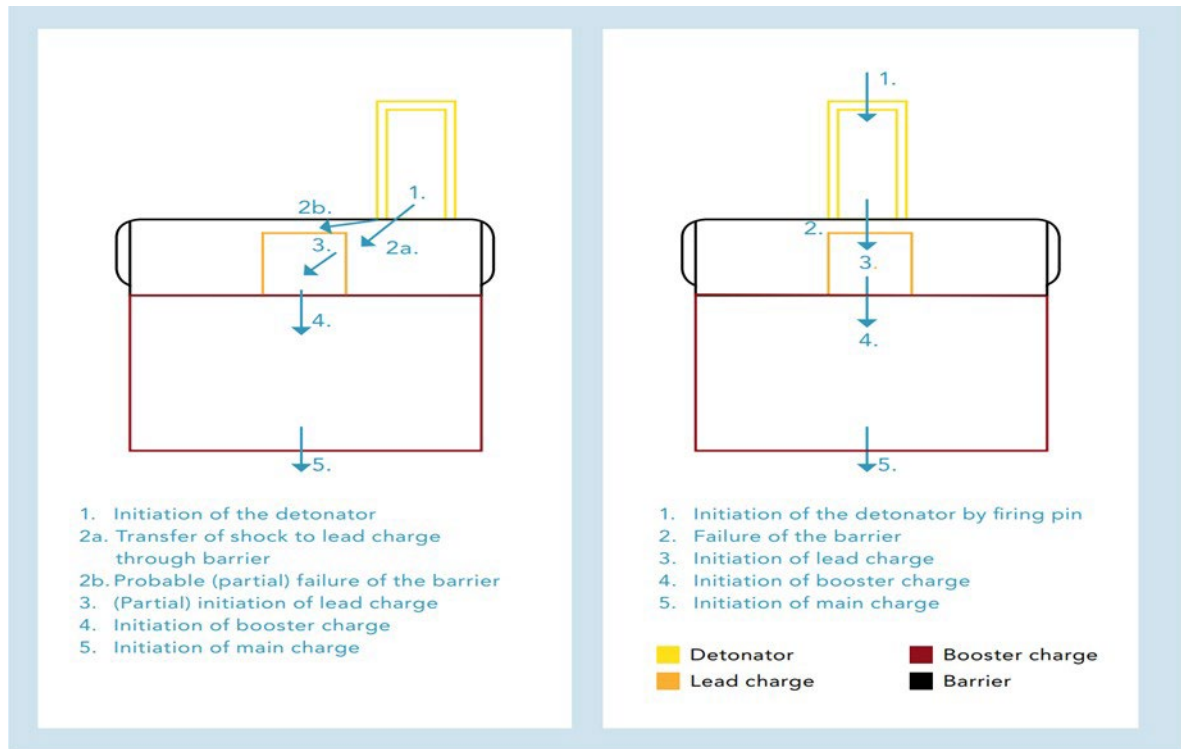
One possibility may be that the key variable is the extent to which the energy of the lead/booster charge is partitioned between deflagration and detonation. When the detonator is in the armed position (Figure 33, right hand side), the PETN booster is efficiently detonated, maximum shock energy is transmitted to the booster which detonates in turn. Where the

Figure 33: Explosive train for an unarmed fuze (left) and an armed fuze (right). (Source: TNO)
