FIELD ASSESSMENT JAVA SEA

SURVEY OF THREE DUTCH WWII NAVAL WRECK SITES IN THE JAVA SEA

Progress Report

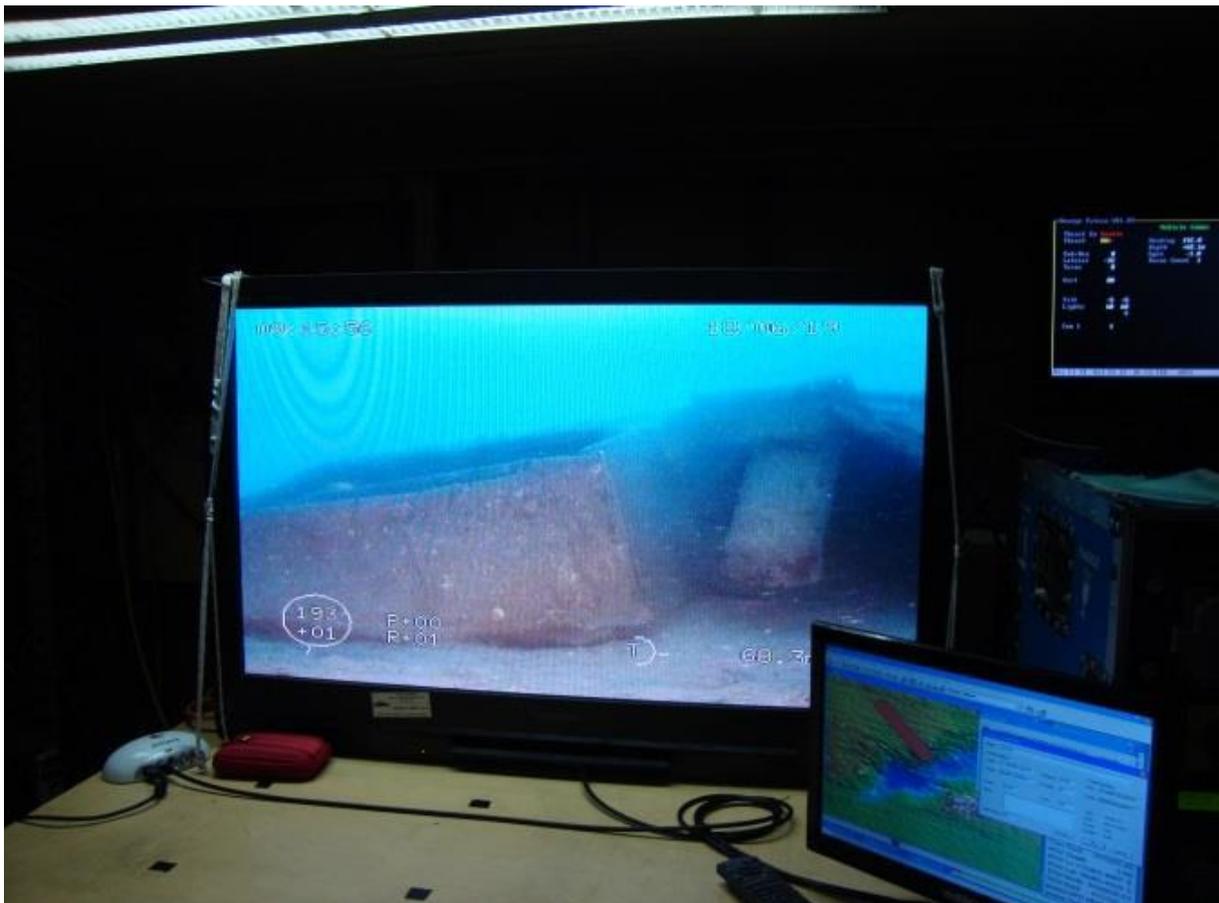
At the location of the *Kortenaer*, the already known ship section is particularly recognizable. This ship section is also visible on video made by the dive team in 2016. The height of this ship section is up to 10 meters in some places. Quite substantially, but the metal is very badly damaged and visibly pinched during the illegal salvage. Not much other parts were found around the ship section. The large part makes up somewhere between 10 and 15% of the total wreck, which was also the estimation of the dive team in 2016. The data has to be analysed further to make a more detailed estimate. No personal items were spotted while mapping the site with the ROV.

Figure 2: A photo made of the monitor during an ROV run.
